Mr. Wayne Lee  
Los Angeles County Public Works  
900 South Fremont Avenue, 9th Floor  
Alhambra, California 91803

**Re: *Devil's Gate Reservoir Restoration Project – Phase 1 Restoration Qualitative Monitoring Conducted on February 23, 2022***

Qualitative monitoring was conducted by Carley Lancaster on February 23, 2022. Field data collected during the monitoring event is provided as Attachment A. This report documents the fourth quarterly qualitative monitoring visit for the Phase 1 mitigation areas.

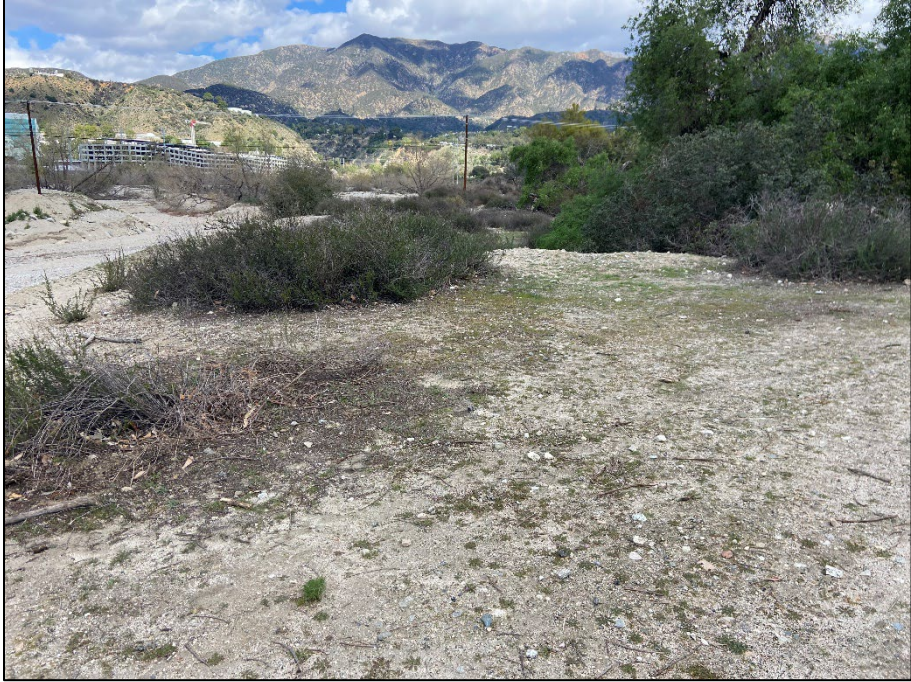
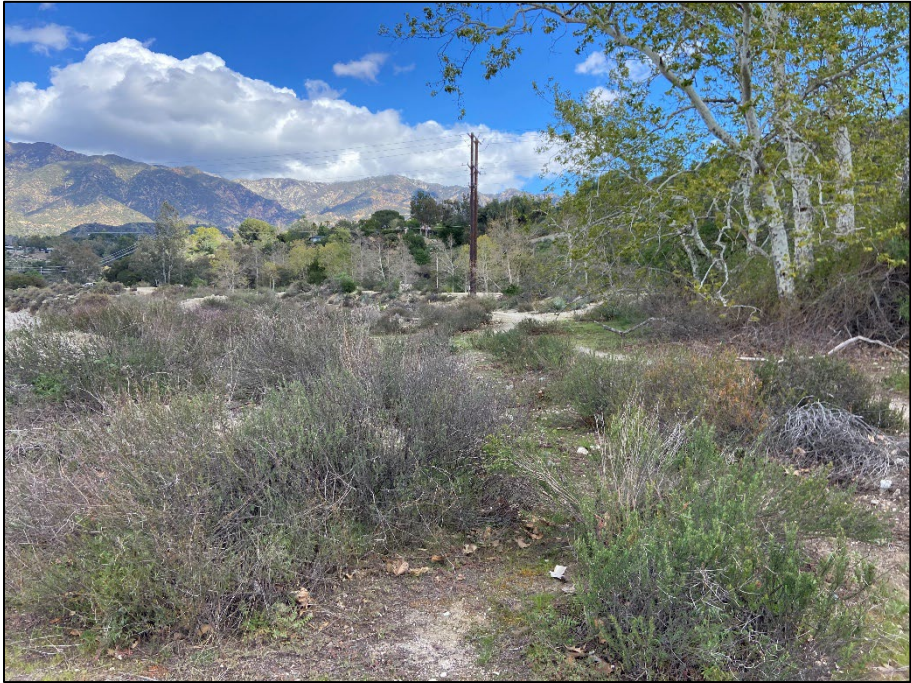
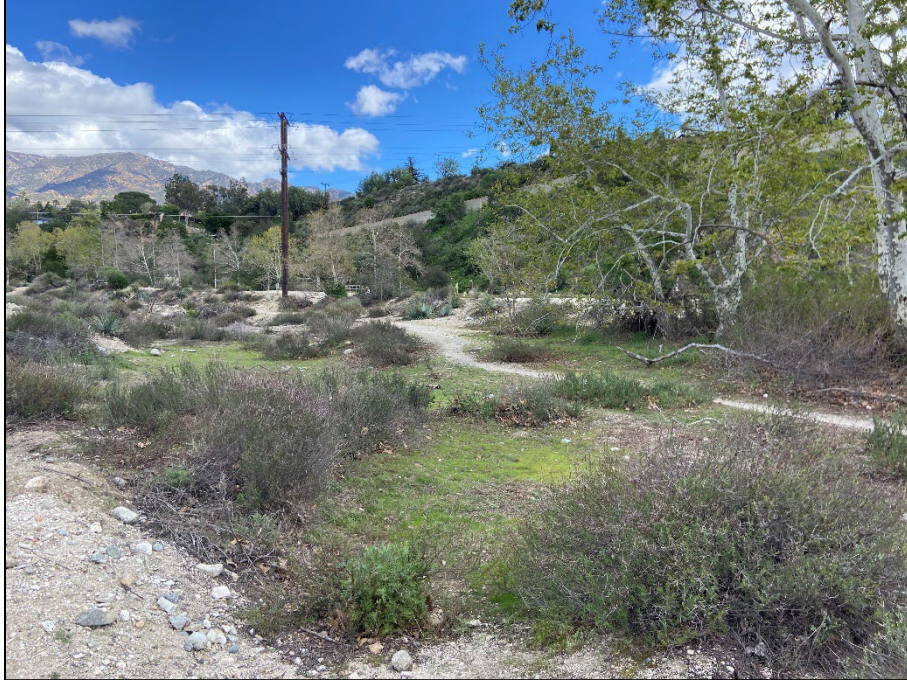
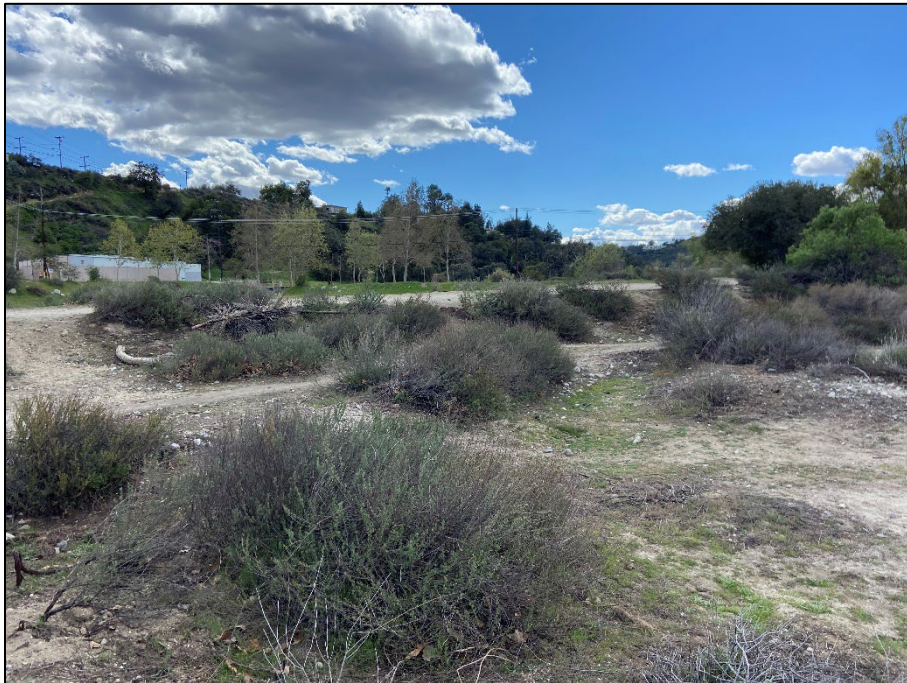
Container plants were not installed in the DG-1 or DG-1 WOUS mitigation areas, but these areas were seeded with native plant species. Native plant growth was noted throughout the DG-1 and DG-1 WOUS mitigation areas, likely both from natural recruitment and from seeding; however, germination was observed to be very minimal in the majority of these mitigation areas. Portions of DG-1 WOUS were noted as being scoured during the 2020 wet season and had minimal plant growth. Native plants such as California sagebrush (*Artemisia californica*), miniature suncup (*Camissoniopsis micrantha*), common sandaster (*Corethrogyne filaginifolia*), California buckwheat (*Eriogonum fasciculatum*), and caterpillar phacelia (*Phacelia cicutaria*) were observed sprouting in the DG-1 and DG-1 WOUS mitigation areas. Dodder (*Cuscuta sp.*) that was noted growing on shrubs in this mitigation area during previous monitoring visits appeared to have been removed or was dead. Native cover for the DG-1 and DG-1 WOUS mitigation areas was estimated to be 55 to 60 percent with some areas having relatively dense cover and other areas being scoured and/or having minimal cover. Photos 1 through 4 in Attachment B document the mitigation area during the monitoring visit.

Nonnative weed cover in DG-1 and DG-1 WOUS was estimated at approximately two percent, which is approximately three percent lower than the level of weed cover that was observed during the previous qualitative monitoring event. Nonnative species observed in DG-1 and DG-1 WOUS included black mustard (*Brassica nigra*), ripgut brome (*Bromus diandrus*), red-stemmed filaree (*Erodium cicutarium*), and Mediterranean grass (*Schismus barbatus*). All nonnative weeds were just starting to germinate and had not gone to flower or seed.

Photo 1: Overview Mitigation Area DG-1

Photo 2: Overview Mitigation Area DG-1

Photo 3: Overview Mitigation Area DG-1

Photo 4: Overview Mitigation Area DG-1

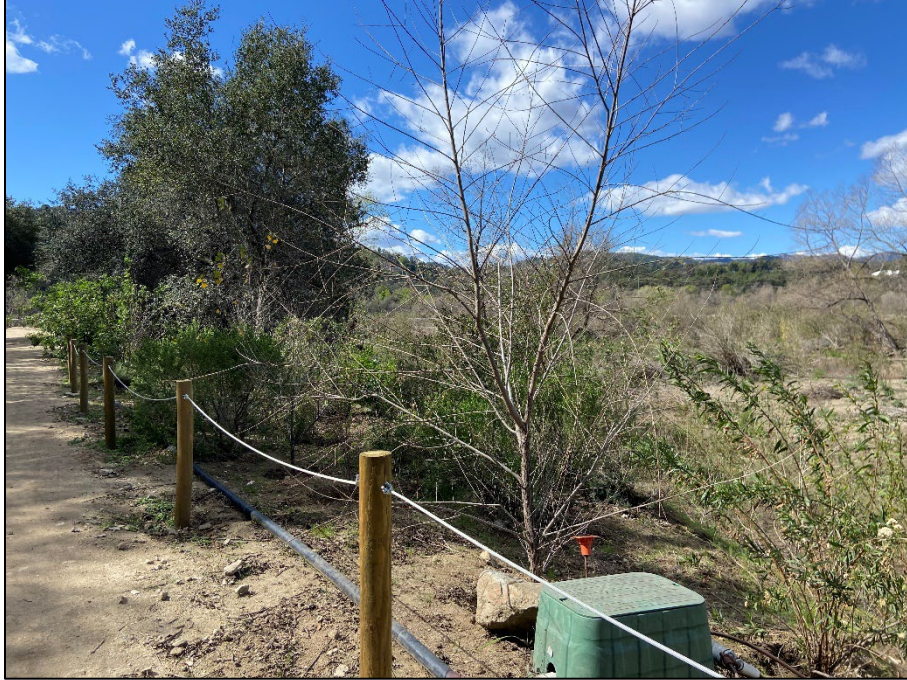
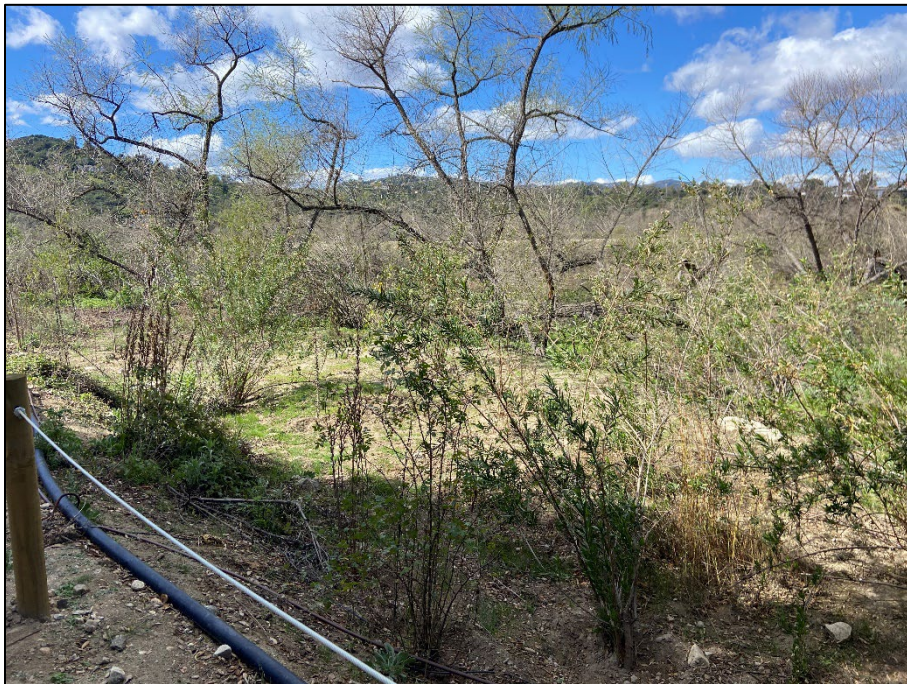
approximately the same as the percentage of container plants that were showing stress during the previous qualitative monitoring event. Stress may be occurring as a result of 1) herbivory by rabbits or other wildlife, 2) competition from nonnative and invasive weeds, 3) misplaced emitters, or 4) recreational traffic through the mitigation areas. There were no additional container plants noted as being missing or dead. Formal mortality counts were taken for DG-2A during the 2020 quantitative monitoring and were included in the 2020 annual reporting. Seasonal dieback was noted for the willows (*Salix* sp.) and the Fremont's cottonwoods (*Populus fremontii*). Some of the planting basins were observed to have minor erosion and should be repaired. The installation of plants in the DG-2A mitigation area appears to have been completed successfully. The current issues identified during the monitoring visit are not expected to have an effect on the continued growth of the plants in the mitigation area. Photos 5 through 6 in Attachment B document the mitigation area during the monitoring visit.

Native plant growth was noted throughout the DG-2A mitigation area, likely both from natural recruitment and from seeding. Native plants such as mugwort (*Artemisia douglasiana*), telegraph weed (*Heterotheca grandiflora*), wild cucumber (*Marah macrocarpa*), caterpillar phacelia, and stinging nettle (*Urtica dioica*) were observed sprouting in the DG-2A mitigation area. Native cover for the DG-2A mitigation area was estimated to be 50 to 55 percent.

Nonnative weed cover in DG-2A was estimated at approximately less than one percent, which is approximately four percent lower than the level of weed cover that was observed during the previous qualitative monitoring event. This site appeared to have been recently weeded during the monitoring visit. Nonnative species observed in DG-2A included black mustard, foxtail barley (*Hordeum murinum*), and perennial pepperweed (*Lepidium latifolium*). All nonnative weeds were just starting to germinate and had not gone to flower or seed.

Photo 5: Overview Mitigation Area DG-2A

Photo 6: Overview Mitigation Area DG-2A

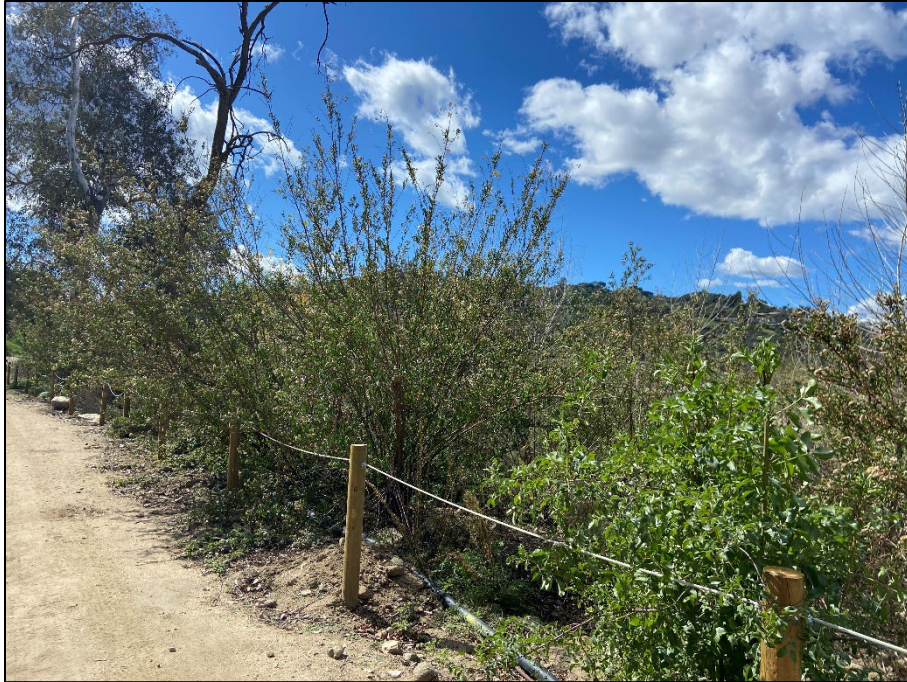
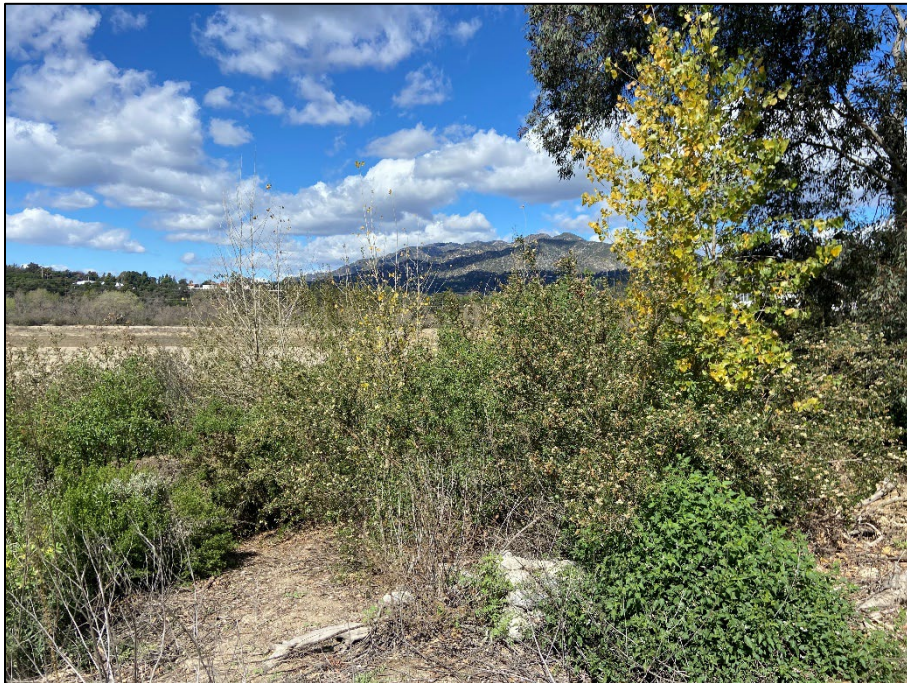
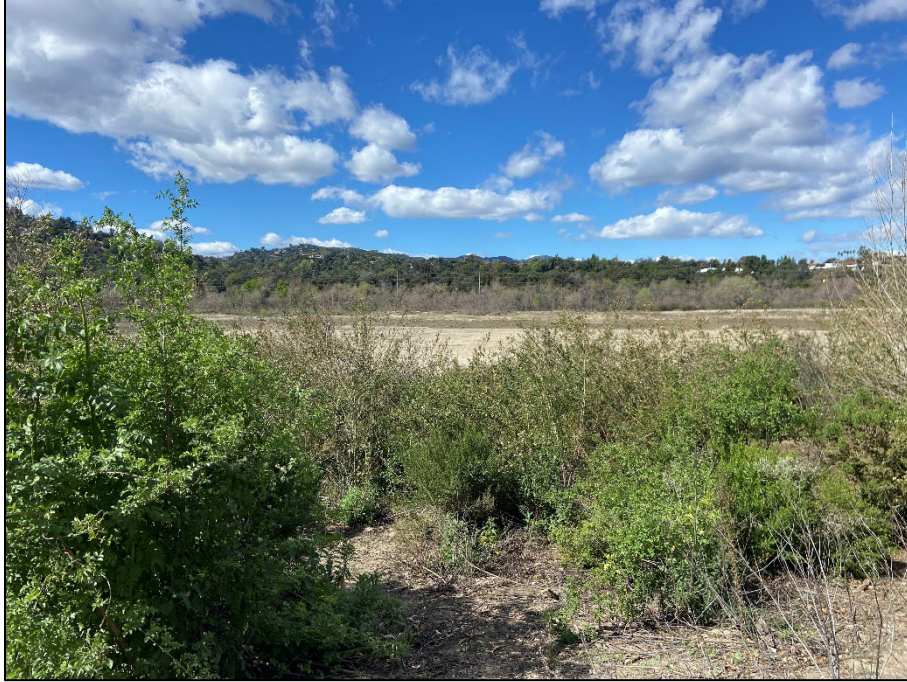
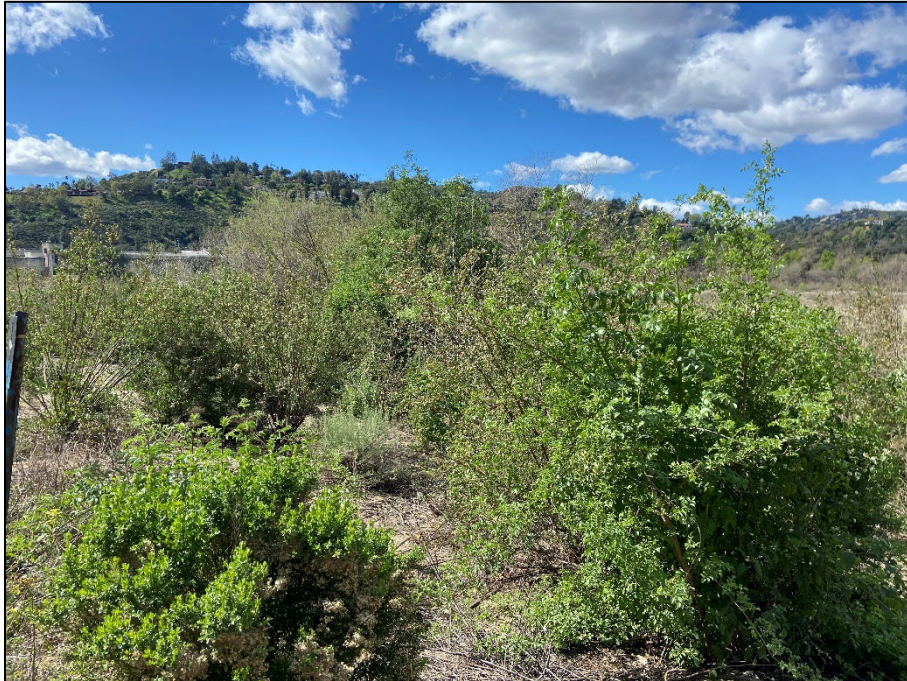
The overall health of the container plants in DG-2B was noted as being good. Approximately less than five percent of the container plants in DG-2B were noted as showing varied levels of stress, which is approximately the same percentage of container plants that were showing stress during the previous qualitative monitoring event. Stress was likely due to the same reasons as those described for DG-2A. In addition, insect galls were observed on several of the willow species. Formal mortality counts were taken for DG-2B during the 2020 quantitative monitoring and were included in the 2020 annual reporting. Similar to DG-2A, some of the willows and Fremont's cottonwoods were showing signs of seasonal dieback. Some of the planting basins were observed to have minor erosion and should be repaired. The installation of the plants in the DG-2B mitigation area appears to have been successfully completed. The current issues identified during the monitoring visit are not expected to have an effect on the continued growth of plants in the mitigation area. Photos 7 through 10 in Attachment B document the mitigation area during the monitoring visit.

Nonnative weed cover in DG-2B was estimated at approximately less than one percent, which is approximately the same percent that was observed during the previous qualitative monitoring event. Nonnative species observed in DG-2B included black mustard and milk thistle (*Silybum marianum*). All nonnative weeds were just starting to germinate and had not gone to flower or seed. In addition, evidence of recent weeding was observed in the DG-2B mitigation area.

Photo 7: Overview Mitigation Area DG-2B

Photo 8: Overview Mitigation Area DG-2B

Photo 9: Overview Mitigation Area DG-2B

Photo 10: Overview Mitigation Area DG-2B

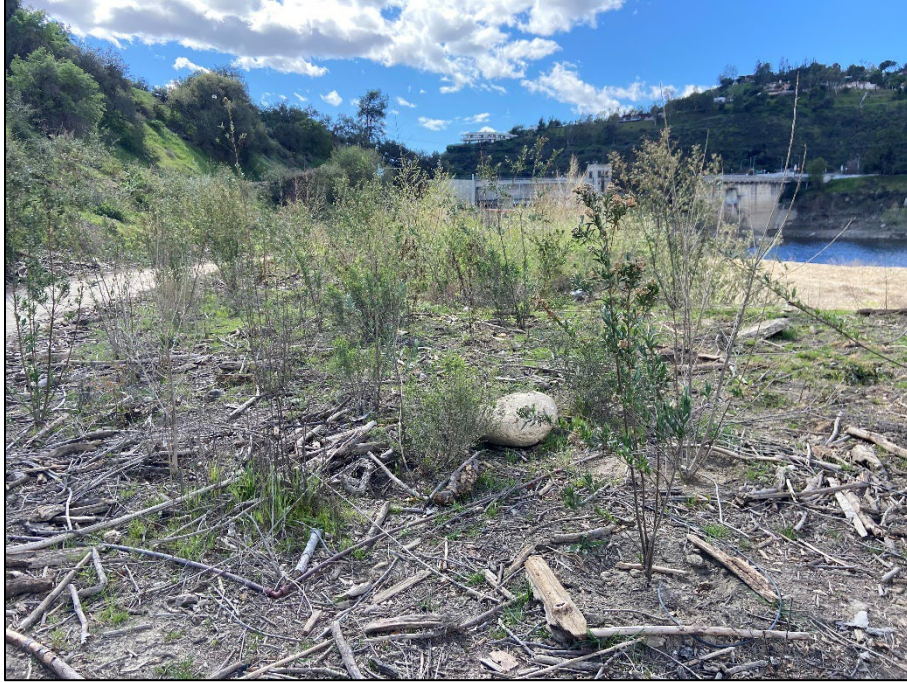
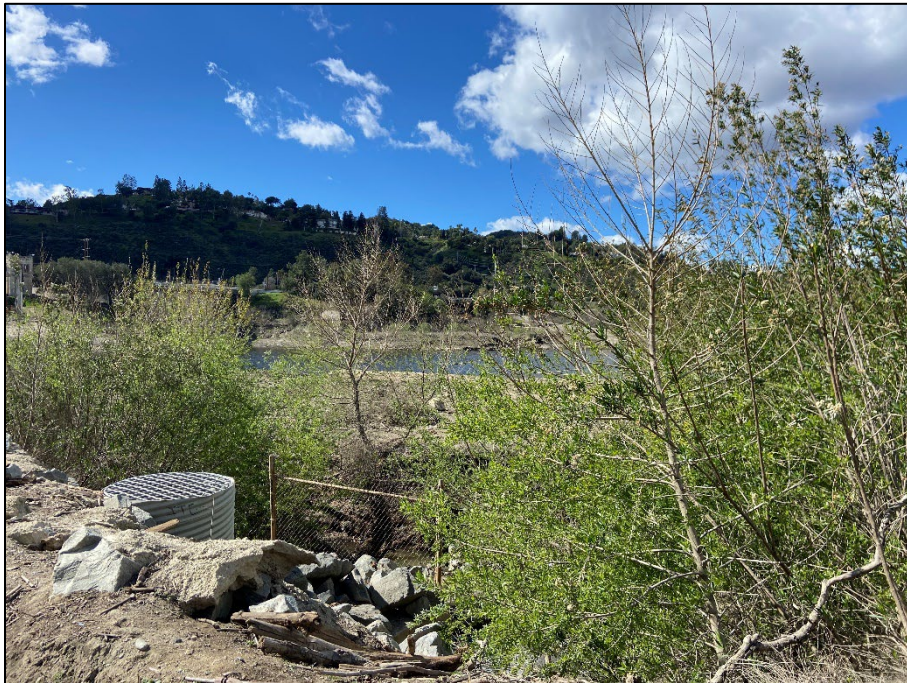
The overall health of the container plants in DG-3A was noted as being good. Approximately five percent of the container plants in the Coast Live Oak Woodland portions of DG-3A were noted as showing varied levels of stress, which is approximately the same as the percentage of container plants that were showing stress during the previous qualitative monitoring event. In addition, six coast live oaks were observed to have been lost due to erosion since the previous monitoring visit. Approximately five to ten percent of the container plants in the Mulefat Thickets portions of DG-3A were noted as showing varied levels of stress, which is approximately five percent higher than the of container plants that were showing stress during the previous qualitative monitoring event. Formal mortality counts were taken for DG-3A during the 2020 quantitative monitoring and were included in the 2020 annual reporting. The types of stress the plants were exhibiting are the same as those described for the plants in DG-2A. However, erosion is also a problem in some areas of DG-3A. In addition, the Mulefat Thickets portions of DG-3A experienced approximately 18-days of inundation following heavy storm events in December of 2021. Most of the container plants appear to be recovering from the inundation. Some of the planting basins were observed to have varied levels of erosion and should be repaired. In addition, portions of the irrigation line appear to have been misplaced during recent storm events and should be fixed. The willow and mulefat stakes were observed to be thriving in this mitigation area. During the monitoring visit, the planted coast live oak acorns were inspected for survivorship and health. Approximately 20 germinated coast live oak acorns appear to still be present in DG-3A. The majority of the germinated acorns appear to be in good health. During the monitoring, it was noted that an existing coast live oak tree (Tree Tag #39) was experiencing severe branch failure for multiple branches. The cause of the branch failure was unclear and further investigation is being conducted. The installation of the plants in the DG-3A mitigation area appears to have been completed successfully. The current issues noted during the monitoring are not expected to have a negative effect on the continued growth of the plants in the mitigation area. Photos 11 through 15 in Attachment B document the mitigation area during the monitoring visit.

Minor erosion to planting basins was observed throughout the Phase 1 mitigation areas, likely from recent storm events. In addition, the severe erosion noted in DG-3A near Altadena Drain during the previous monitoring visit continues to worsen. Recent rainfall has continued to carve a channel that flows to the south of Altadena Drain before connecting to the reservoir where severe berm erosion continues to occur. Erosion to the upper slope in DG-3A was also observed. Due to the steepness of the slope in the Coast Live Oak Woodland portion of the DG-3A mitigation area, erosion will likely continue to be somewhat of an issue in this area; however, jute nettings are currently in place on the slope and will help to lessen the severity of erosion issues. As native cover increases in this area, erosion issues should lessen. The severity of the erosion should continue to be monitored in all planted areas and if warranted, erosion Best Management Practices (BMPs) should be installed in appropriate areas. This may only require the installation of straw wattles at select sites to prevent existing rills from becoming larger. However, until more native perennial plants become established in these areas, there is the potential that intense rainfall may create additional erosion problems.

Photo 11: Overview Mitigation Area DG-3A Altadena Drain

Photo 12: Overview Mitigation Area DG-3A Altadena Drain

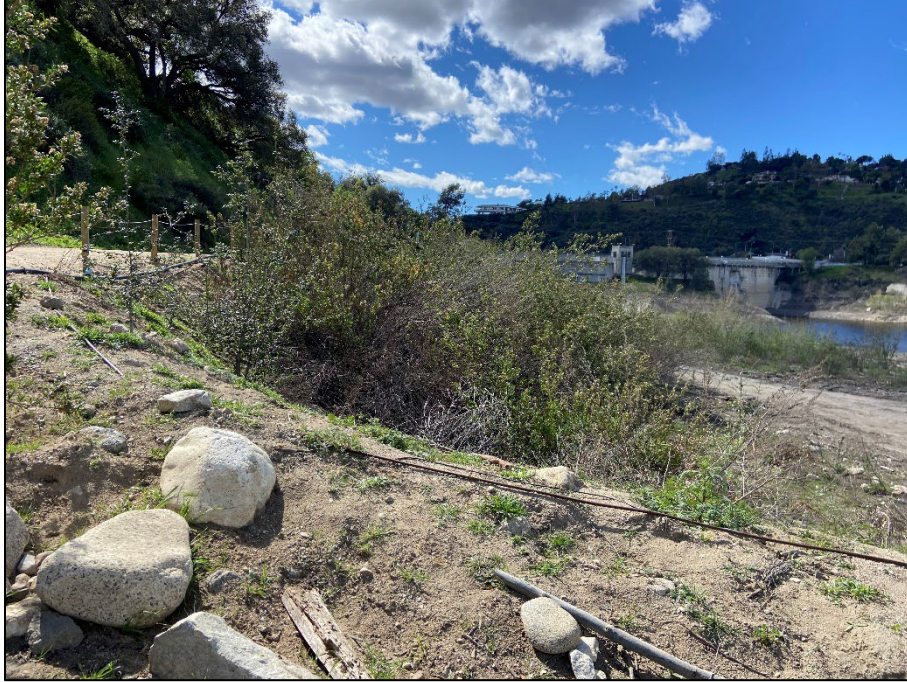
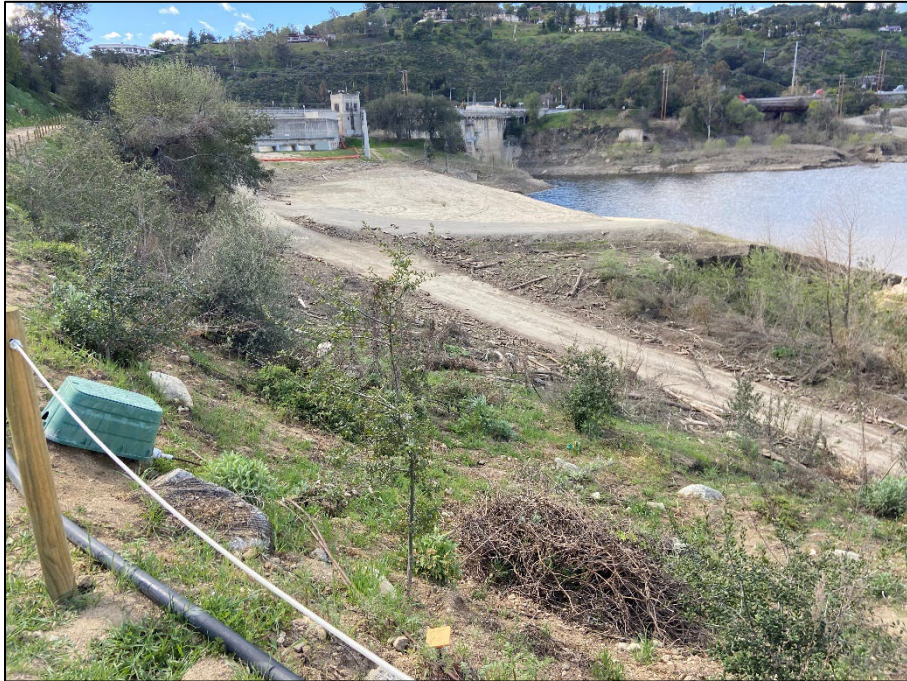
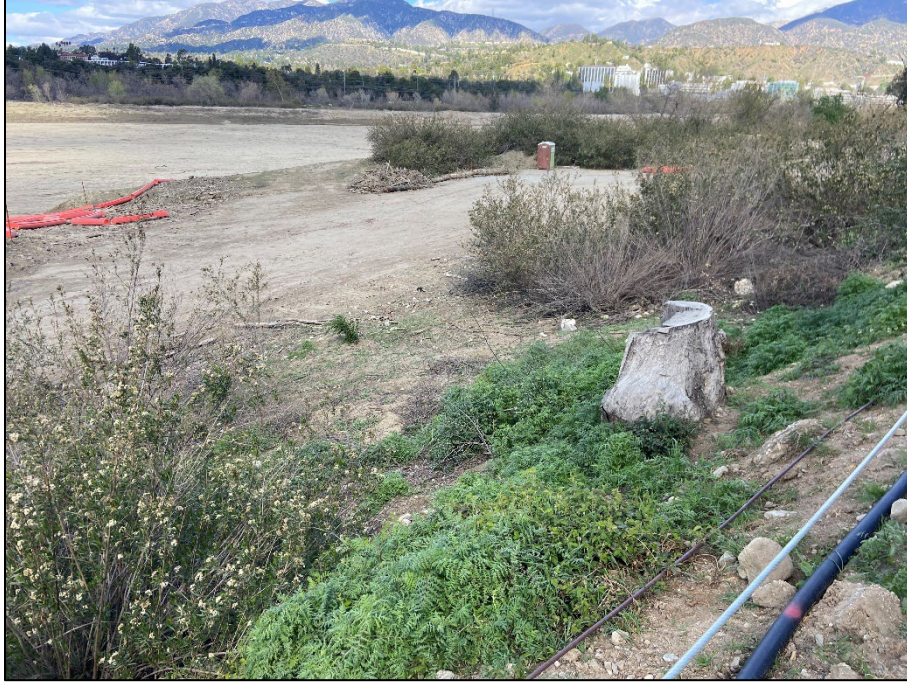
Native plant growth was noted throughout the DG-3A mitigation area, likely both from natural recruitment and from seeding. Native plants such as mugwort, mulefat, miniature suncup, telegraph weed, caterpillar phacelia, and stinging nettle were observed sprouting in the DG-3A mitigation area. Native cover for the DG-3A mitigation area was estimated to be approximately 55 percent in the mulefat thickets portion of the mitigation area and 45 percent in the coast live oak woodland portion (50 percent overall).

Nonnative weed cover in DG-3A was estimated at approximately 10 percent, which is approximately the same percentage of nonnative cover that was observed during the previous qualitative monitoring event.

Photo 13: Overview Mitigation Area DG-3A Oak Woodland

Photo 14: Overview Mitigation Area DG-3A Oak Woodland

Photo 15: Overview Mitigation Area DG-3A Oak Woodland

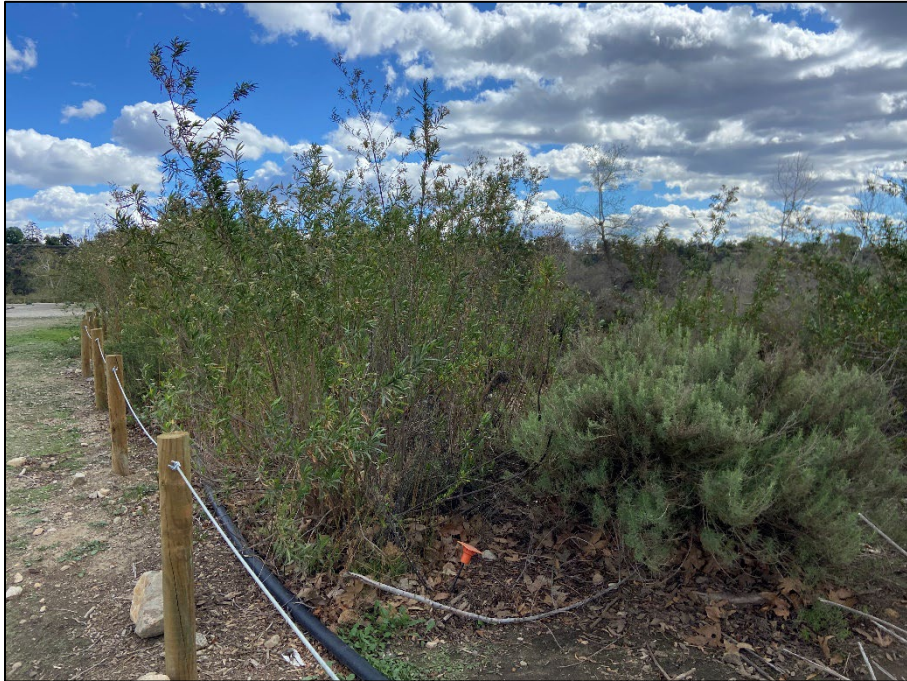
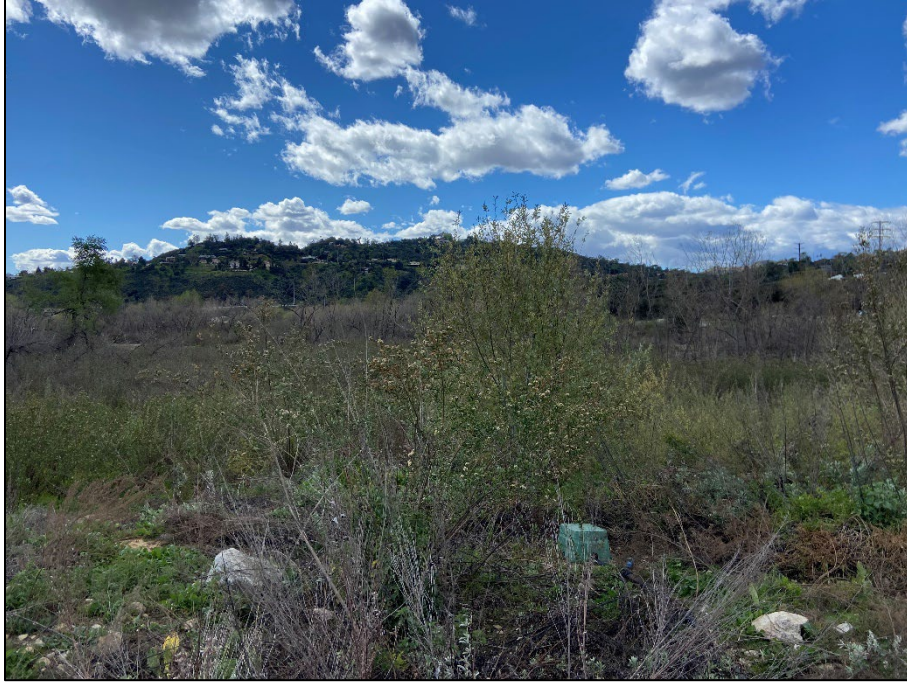
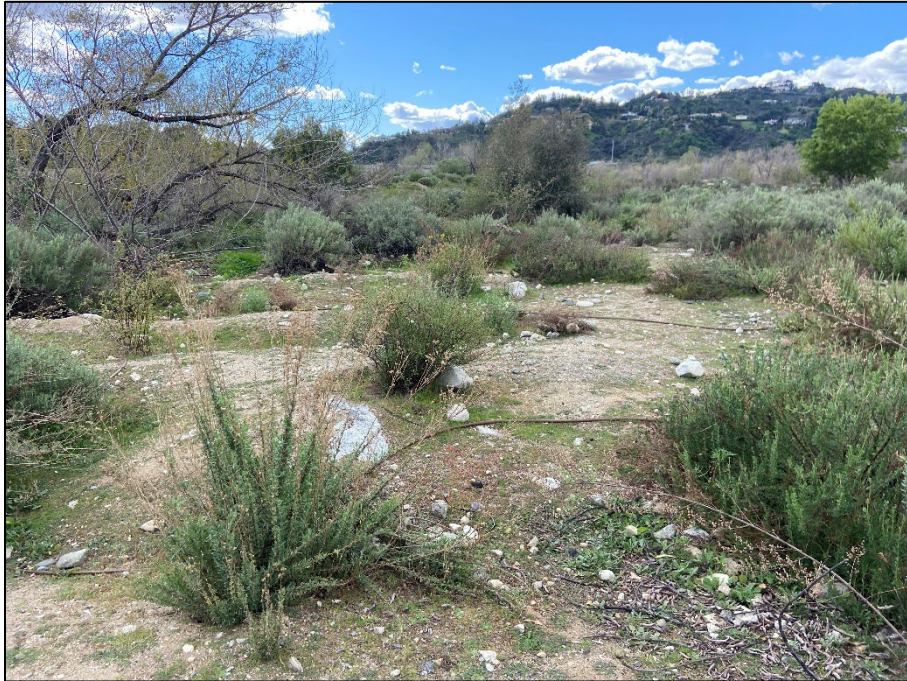
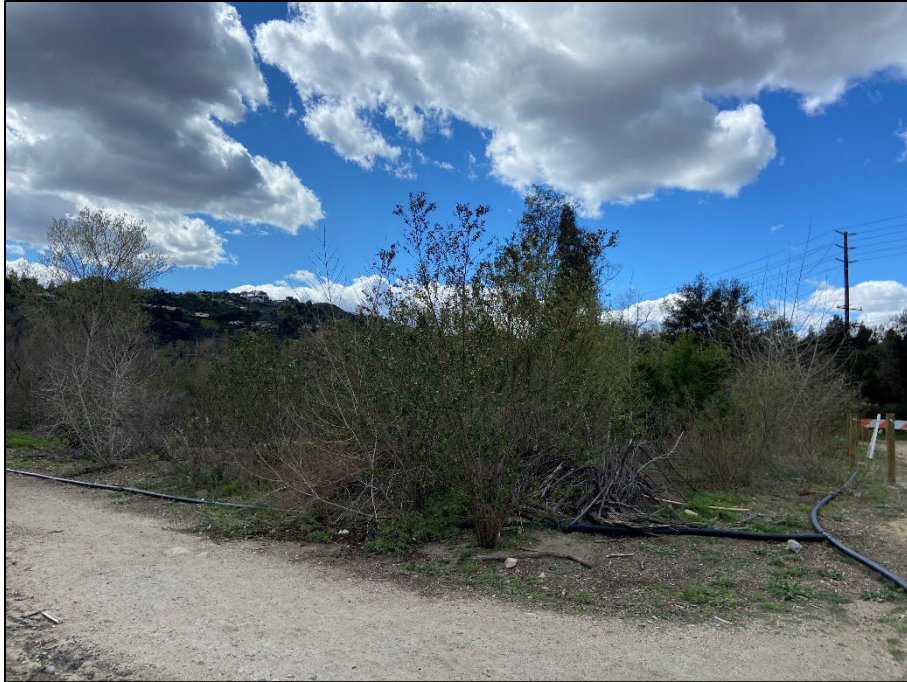
The overall health of the container plants in mitigation area DG-4 was noted as being good. Approximately five percent of container plants in the coastal sage scrub portions of DG-4 were showing varied levels of stress which is approximately the same percentage of plants showing stress during the previous qualitative monitoring event. Approximately five percent of container plants in the majority of the riparian portions of DG-4 were showing varied levels of stress, which is approximately the same as the percentage of plants showing stress during the previous qualitative monitoring event. It should be noted that approximately 15 percent of the container plants in the southern sections of DG-4, where extended inundation occurred following heavy storm events in December 2021, were showing signs of moderate stress; however, many were starting to show signs of recovery and new growth. Other causes of stress appear to be mostly due to the same reasons described in DG-2A. For most portions of DG-4, only a negligible number of container plants were noted as being missing or dead. Formal mortality counts were taken for DG-4 during the 2020 quantitative monitoring and were included in the 2020 annual reporting. Similar to DG-2A, some of the willows and Fremont's cottonwoods were showing signs of seasonal dieback. Some of the planting basins were observed to have minor erosion and should be repaired. The installation of plants in the DG-4 mitigation area appears to have been completed successfully and the issues noted during the monitoring are not expected to have an impact on the continued growth of the plants. Photos 16 through 19 in Attachment B document the mitigation area during the monitoring visit.

Nonnative weed cover in DG-4 was estimated at approximately 10 to 40 percent, which is approximately 30 percent higher than the percentage of nonnative cover that was observed during the previous qualitative monitoring event. Nonnative species observed in DG-4 included black mustard, cheatgrass (*Bromus tectorum*), poison hemlock (*Conium maculatum*), red-stemmed filaree, foxtail barley, perennial pepperweed, and white horehound (*Marrubium vulgare*). Nonnative weed cover, especially perennial pepperweed, is a significant problem in portions of the DG-4 mitigation area. Because perennial pepperweed can produce dense colonies through seed germination and underground rhizomes (rhizomatous roots), removal of this species without the use of systemic herbicide is very difficult. Most nonnative weeds were just starting to germinate and had not gone to flower or seed.

Photo 16: Overview Mitigation Area DG-4

Photo 17: Overview Mitigation Area DG-4

Photo 18: Overview Mitigation Area DG-4

Photo 19: Overview Mitigation Area DG-4

Nonnative weed cover ranged from approximately 2 percent to 40 percent in the various mitigation areas and it was noted that weed cover was highest in the middle and southern sections of DG-4. It should be noted that many of the annual nonnative weeds in these areas were dead for the season. In addition, nearly all nonnative weeds observed during the monitoring were just starting to germinate and had not gone to flower or seed. Regular maintenance and removal of nonnative weeds is of the highest priority for all of the mitigation areas to reduce competition between native and nonnative plants. In addition, eucalyptus stumps that are starting to re-sprout should be trimmed back frequently. A focus should be placed on removing the weeds and nonnatives from the basins of each of the container plants and cuttings; however, nonnative weeds just outside of the planting areas can migrate into the planting areas via seed dispersal. Outside of the nesting bird season, a focus should also be made to remove nonnative weeds in areas where least Bell's vireos are likely to nest during the breeding season (i.e. in the vicinity of the least Bell's vireo nest that was active in 2020). Nonnative plants and weeds that have gone to seed should be bagged and removed from the mitigation area. Without the use of herbicides, control of the nonnatives will be extremely difficult so the frequency and level of effort will need to be increased to provide control until the native plants and seedlings have a chance to grow and outcompete the nonnatives. In particular, it is important to maintain long-term perennial pepperweed management to reduce competition and allow for native plants to germinate. In addition, dodder should be removed from container plants in the mitigation areas. Although many species of dodder are native, this parasitic plant can be harmful to younger shrubs and trees that are not yet established and can even cause mortality.

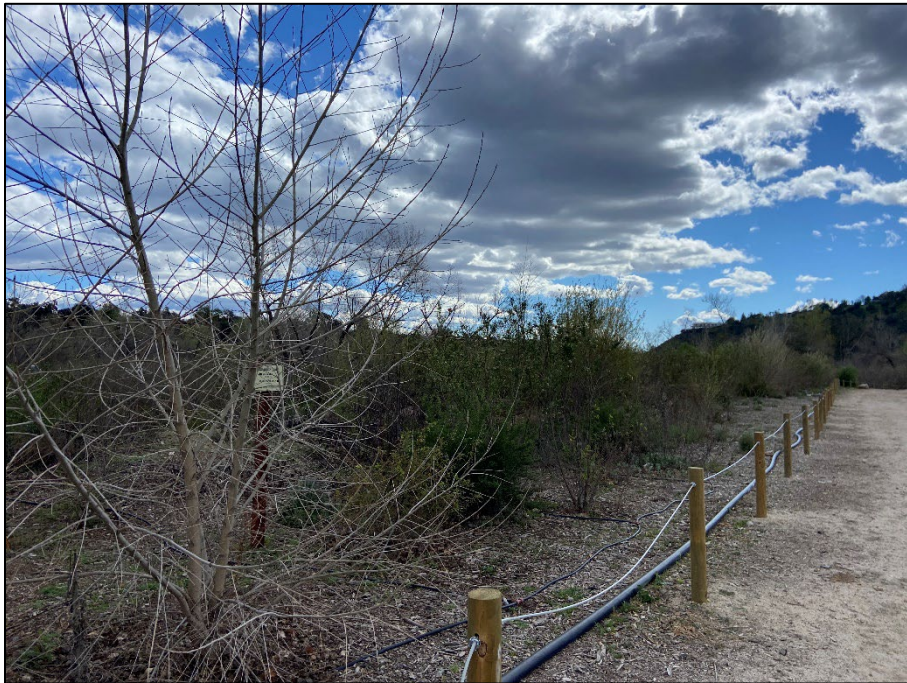
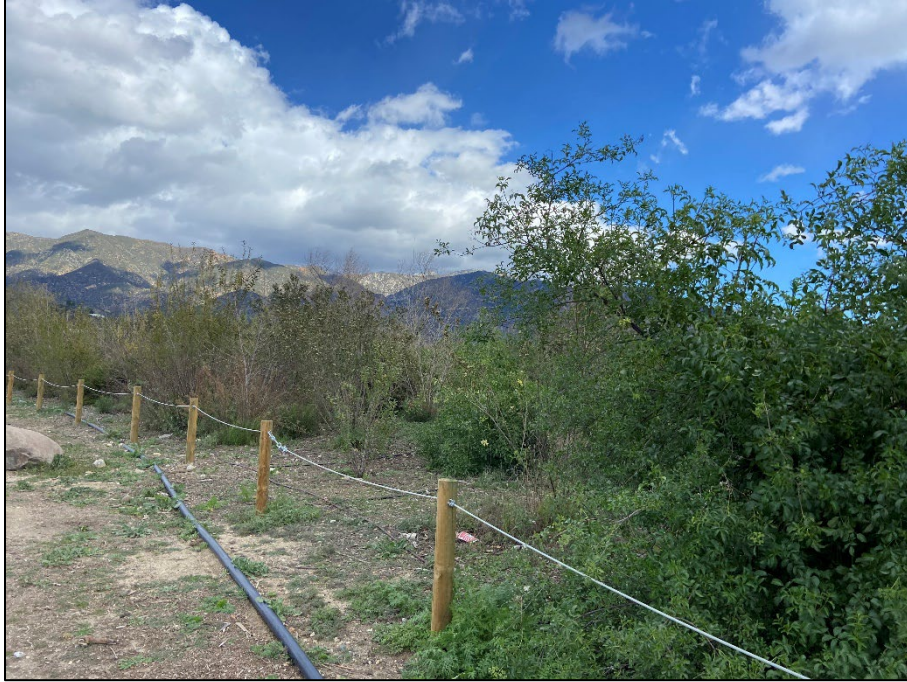
The overall health of the container plants in mitigation area DG-4B was noted as being good and this mitigation area is becoming well established. Approximately less than five percent of container plants were showing stress which is approximately the same percent of plants that were stressed during the previous qualitative monitoring event. The types of stress the plants were exhibiting are the same as those described for the plants in DG-2A. A negligible number of container plants were noted as being missing or dead. Formal mortality counts were taken for DG-4B during the 2020 quantitative monitoring and were included in the 2020 annual reporting. Some of the planting basins were observed to have minor erosion and should be repaired. The installation of plants in the DG-4B mitigation area appears to have been completed successfully and the issues noted during the monitoring are not expected to have an impact on the continued growth of the plants. Photos 20 and 21 in Attachment B document the mitigation area during the monitoring visit.

Nonnative weed cover in DG-4B was estimated to be approximately 10 percent, which is approximately five percent more than the percentage of nonnative cover that was observed during the previous qualitative monitoring event. Nonnative species observed in DG-4B included black mustard, poison hemlock, and perennial pepperweed. All nonnative weeds were just starting to germinate and had not gone to flower or seed.

Photo 20: Overview Mitigation Area DG-4B

Photo 21: Overview Mitigation Area DG-4B

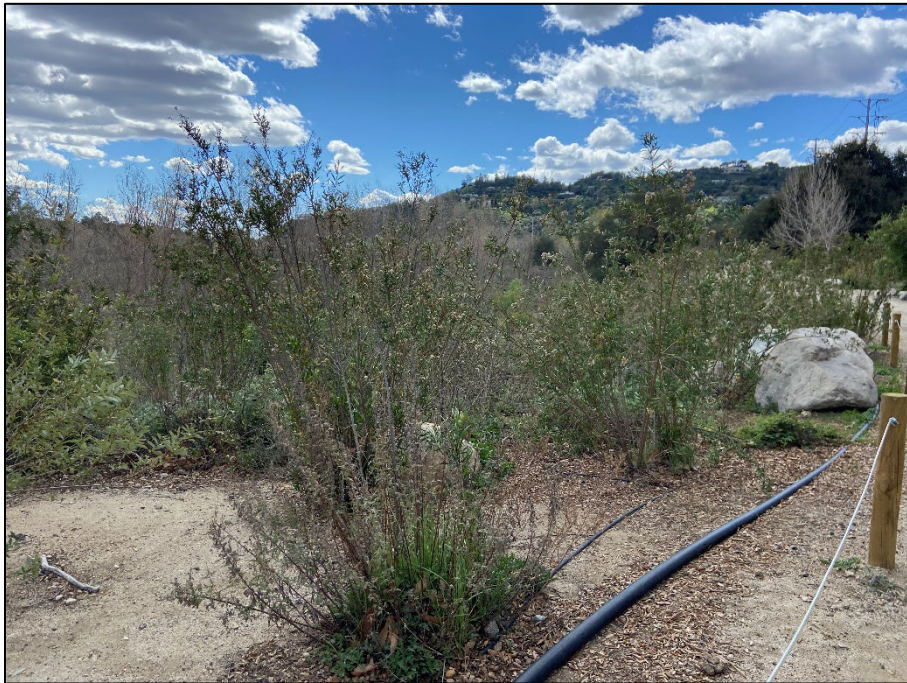
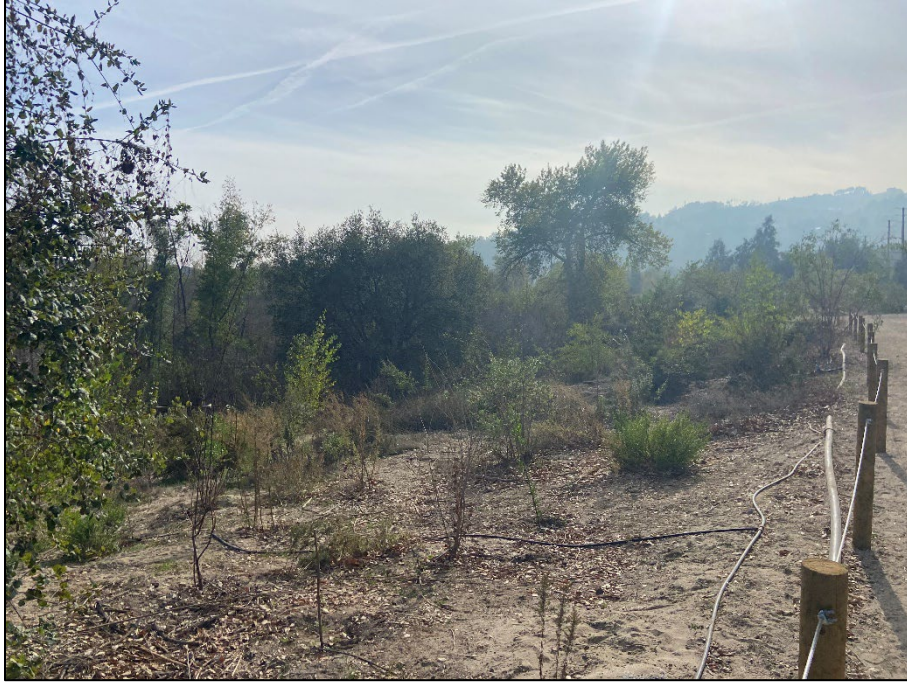
The overall health of the container plants in mitigation area DG-4C was noted as being good. Approximately less than five percent of all container plants were noted as showing minor levels of stress, which is approximately five percent less than percentage of plants that were showing stress during the previous qualitative monitoring event. The types of stress the plants were exhibiting are the same as those described for the plants in DG-2A. A negligible number of container plants were noted as being missing or dead. Formal mortality counts were taken for DG-4C during the 2020 quantitative monitoring and were included in the 2020 annual reporting. Some of the planting basins were observed to have minor erosion and should be repaired. The installation of plants in the DG-4C mitigation area appears to have been completed successfully and the issues noted during the monitoring are not expected to have an impact on the continued growth of the plants. Photos 22 to 24 in Attachment B document the mitigation area during the monitoring visit.

Nonnative weed cover in DG-4C was estimated at approximately 10 percent, which is approximately five percent higher than the percentage of nonnative cover that was observed during the previous qualitative monitoring event. Nonnative species observed in DG-4C included black mustard, poison hemlock, foxtail barley, and dwarf nettle (*Urtica urens*). All nonnative weeds were just starting to germinate and had not gone to flower or seed

Photo 22: Overview Mitigation Area DG-4C

Photo 23: Overview Mitigation Area DG-4C

Photo 24: Overview Mitigation Area DG-4C

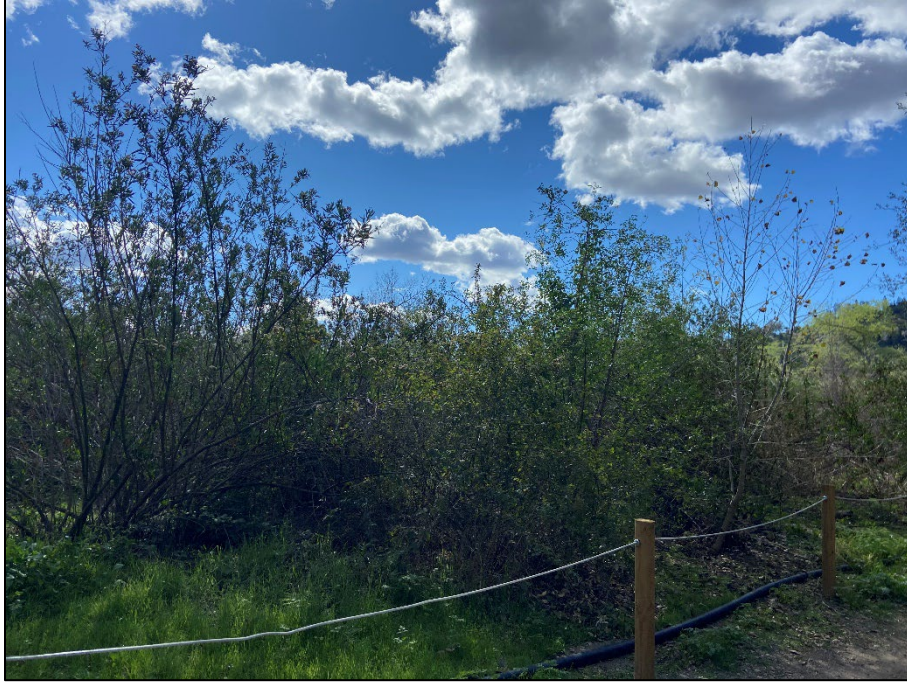
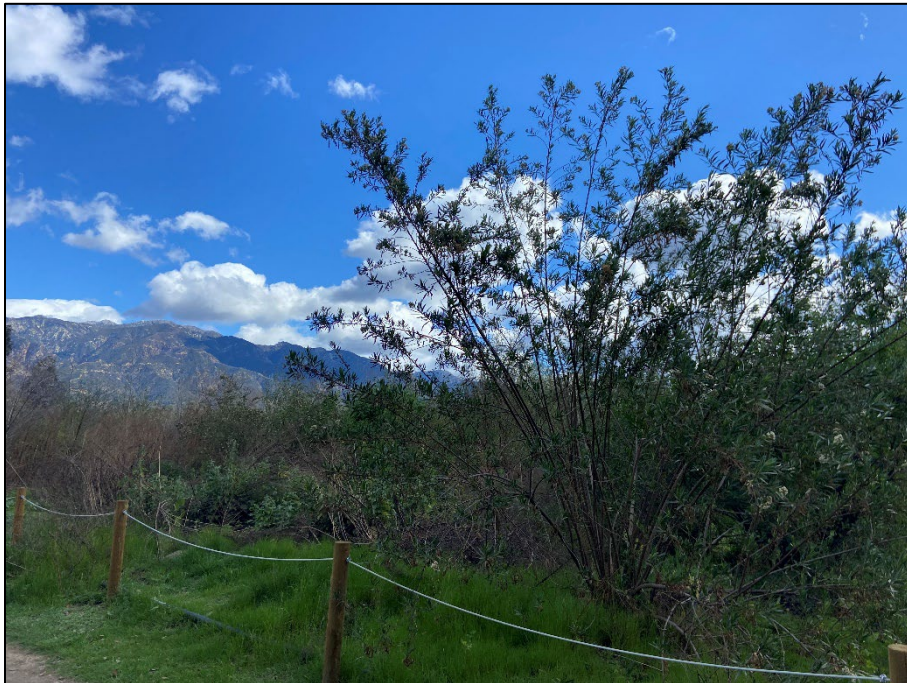
The overall health of the container plants in the DG-5 mitigation area was noted as being good. Approximately less than five percent of all container plants were noted as showing varied levels of stress, which is approximately the same as the percentage of plants that were showing stress during the previous qualitative monitoring event. Formal mortality counts were taken for DG-5 during the 2020 quantitative monitoring and were included in the 2020 annual reporting. Some of the planting basins were observed to have minor erosion and should be repaired. Similar to DG-2A, some of the willows and Fremont's cottonwoods were showing signs of seasonal dieback. The installation of plants in the DG-5 mitigation area appears to have been completed successfully and the issues noted during the monitoring are not expected to have a negative impact on the continued growth of the plants. Photos 25 and 26 in Attachment B document the mitigation area during the monitoring visit.

Nonnative weed cover in DG-5 was estimated at approximately 25 percent, which is approximately 20 percent higher than the percentage of nonnative weed cover that was observed during the previous qualitative monitoring event. Nonnative species observed in DG-5 included black mustard, poison hemlock, foxtail barley, and milk thistle. Most nonnative weeds were just starting to germinate and had not gone to flower or seed

Photo 25: Overview Mitigation Area DG-5

Photo 26: Overview Mitigation Area DG-5
