July 12, 2021  
2018-047.031

**Re: *Devil's Gate Reservoir Restoration Project – Phase 2 Restoration Plant Establishment Period Monitoring Conducted on May 17, 2021***

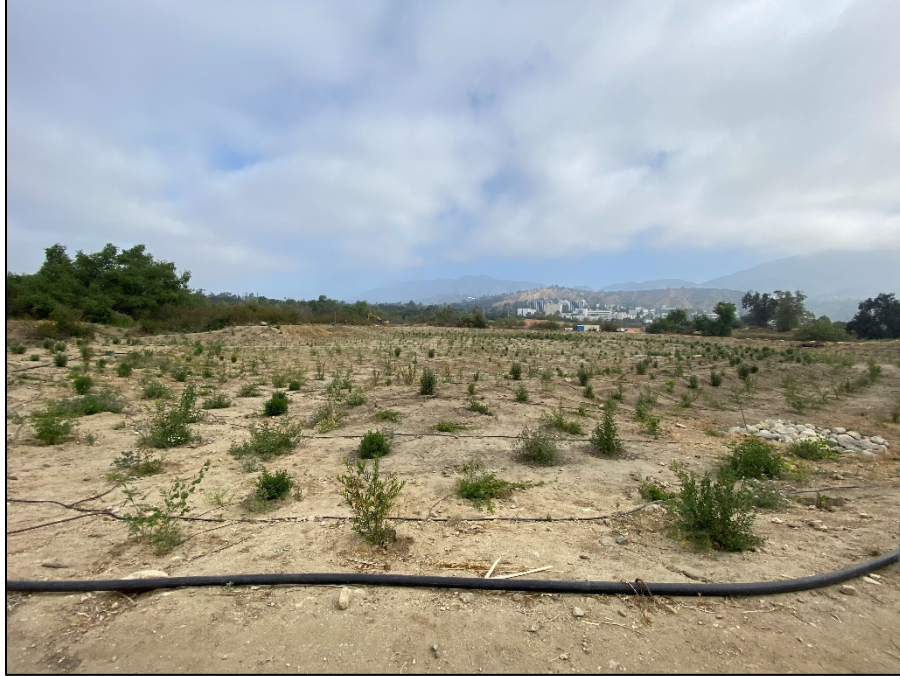
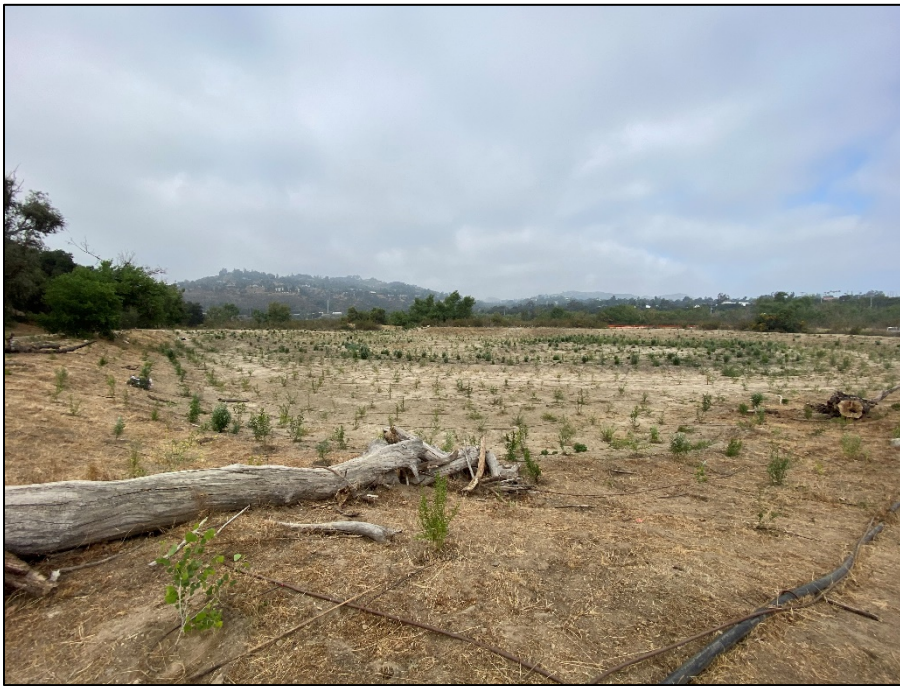
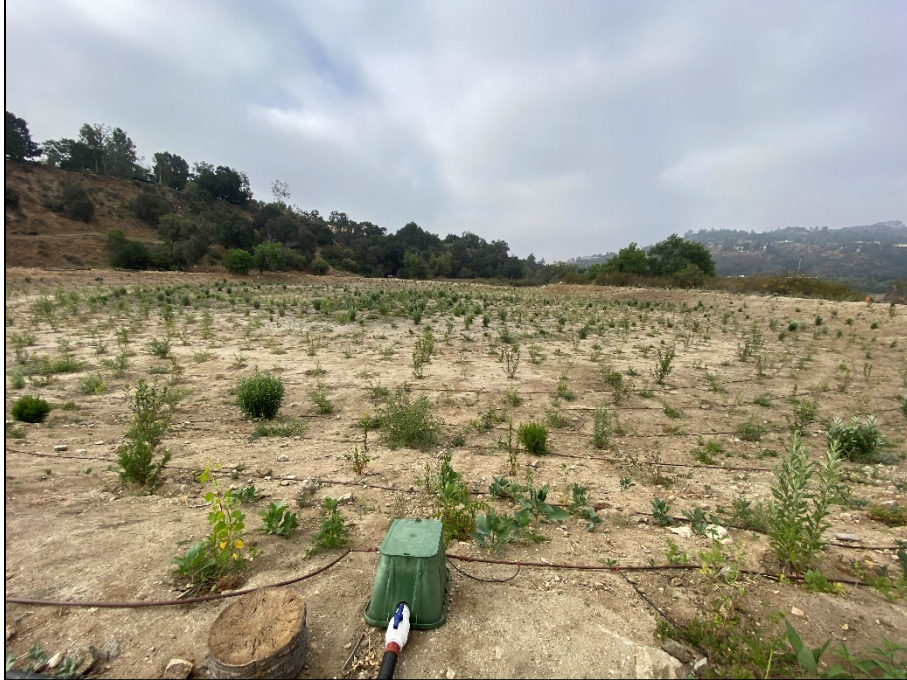
The overall health of the container plants in DG-W-1 was noted as being good. Approximately five percent of the container plants in DG-W-1 were noted as showing varied levels of stress and a negligible number were noted as being dead or missing. Stress may be occurring as a result of 1) transplant shock 2) herbivory by rabbits or other wildlife, 3) competition from nonnative and invasive weeds, 4) misplaced emitters, or 5) recreational traffic through the mitigation areas. Formal mortality counts will be taken for DG-W-1 during the 2021 quantitative monitoring and will be included in the 2021 annual reporting. The willow species (*Salix sp.*) and Fremont's cottonwoods (*Populus fremontii*) in the mitigation areas were no longer showing signs of seasonal dieback. Some of the container plants were noted as lacking well defined basins and should have their basins properly constructed and/or repaired. The installation of plants in the DG-W-1 mitigation area appears to have been completed successfully. The current issues identified during the monitoring visit are not expected to have an effect on the continued growth of the plants in the mitigation area. Photos 1 through 3 in Attachment B document the mitigation area during the monitoring visit.

Nonnative weed cover in DG-W-1 was estimated at approximately 10 percent and crews were beginning to actively weed the area during the monitoring. Nonnative species observed in DG-W-1 included black mustard (*Brassica nigra*), rip-gut brome (*Bromus diandrus*), tocalote (*Centaurea melitensis*), lamb's quarters (*Chenopodium album*), poison hemlock (*Conium maculatum*), red-stemmed filaree (*Erodium cicutaria*) scarlet pimpernel (*Lysimachia arvensis*), and German chamomile (*Matricaria chamomilla*). Many of the

nonnative weeds observed in this mitigation area are starting to flower and will soon go to seed. Weed abatement should be completed for this mitigation area as soon as possible.

Photo 1: Overview Mitigation Area DG-W-1 (Johnson Field)

Photo 2: Overview Mitigation Area Overview Mitigation Area DG-W-1 (Johnson Field)

Photo 3: Overview Mitigation Area Overview Mitigation Area DG-W-1 (Johnson Field)

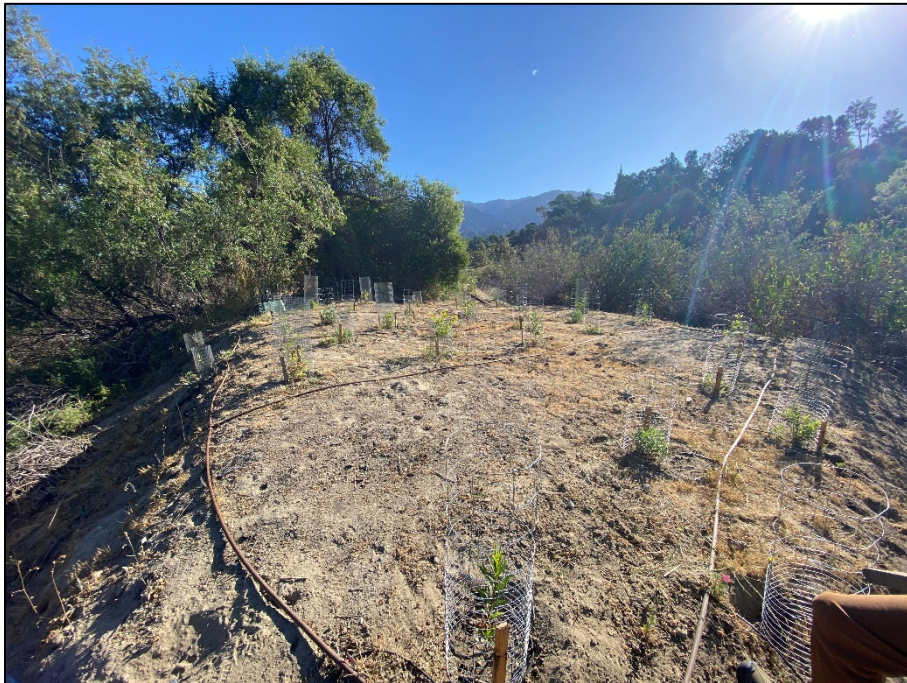
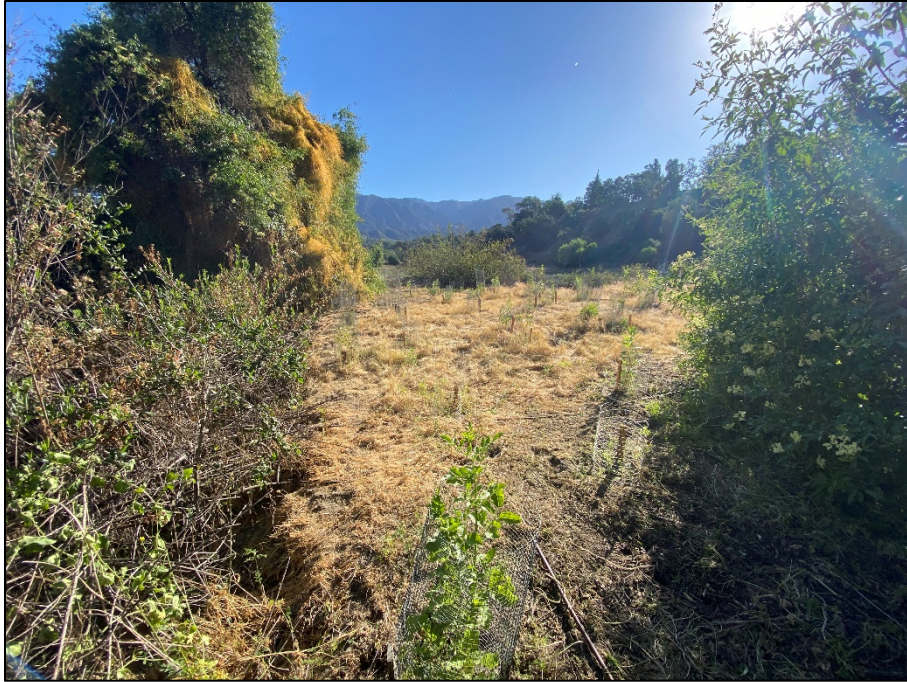
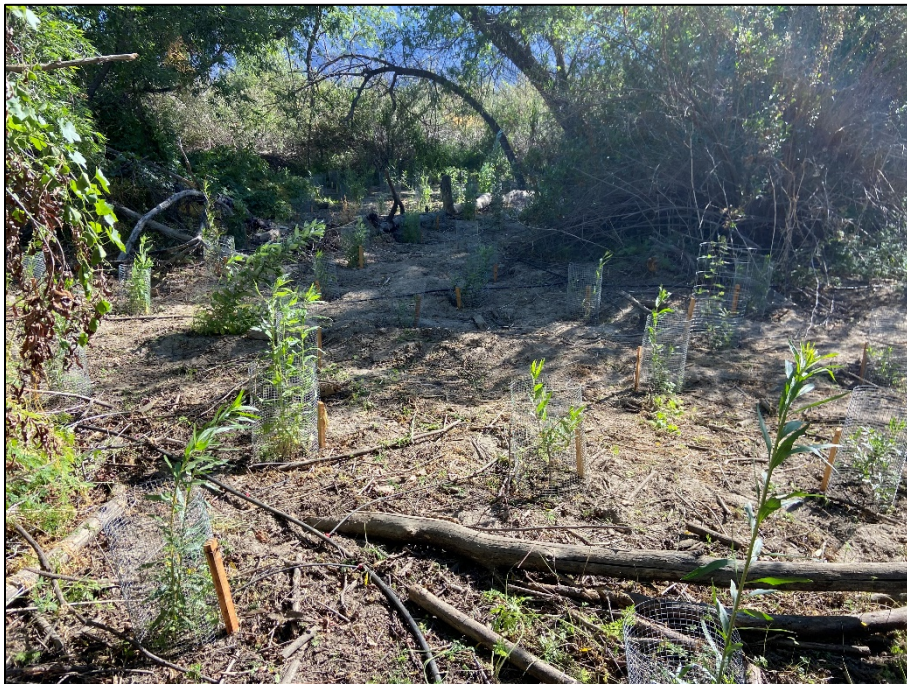
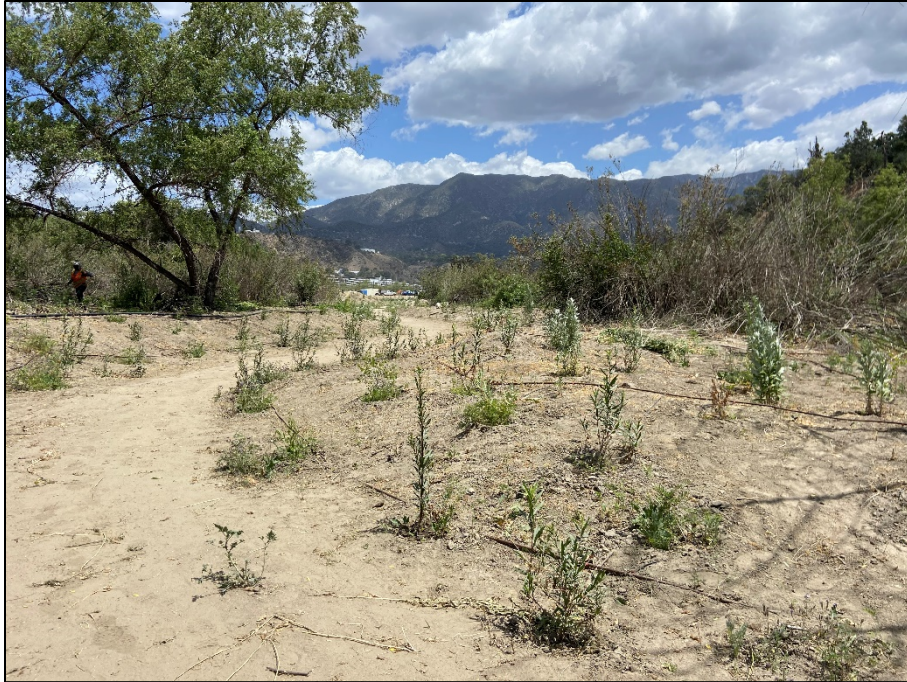
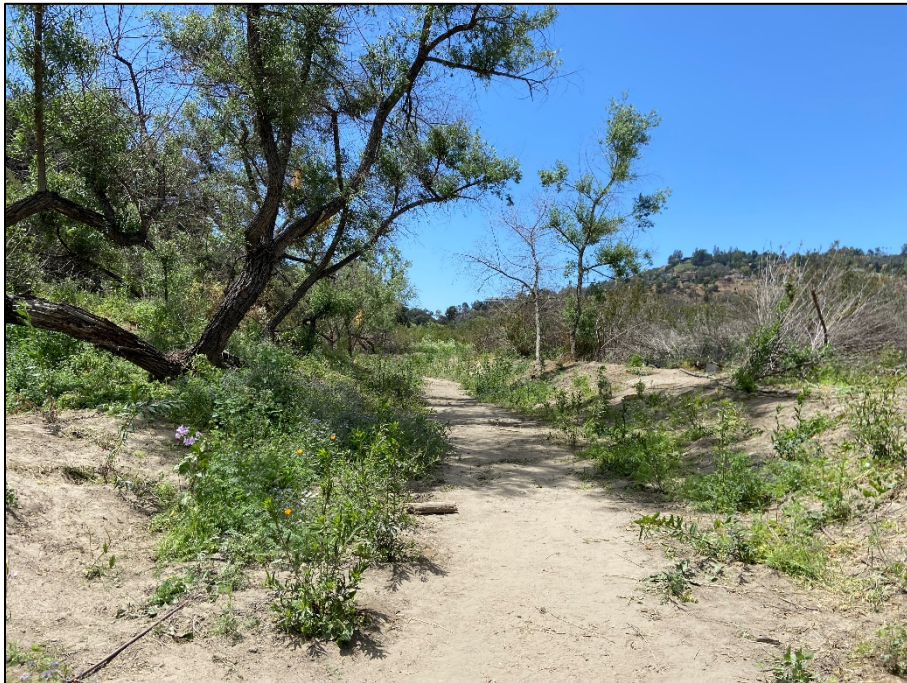
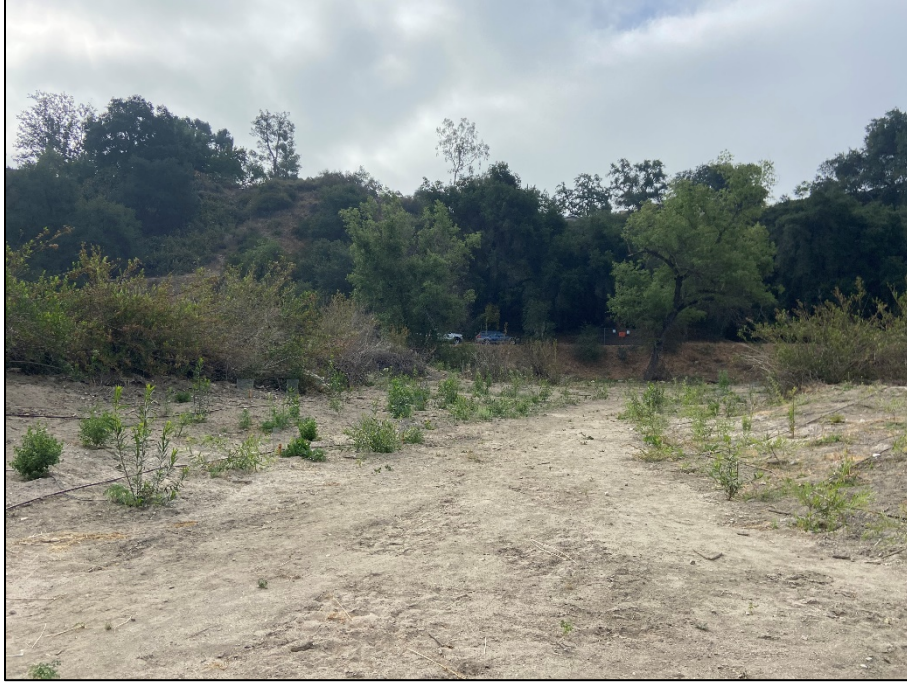
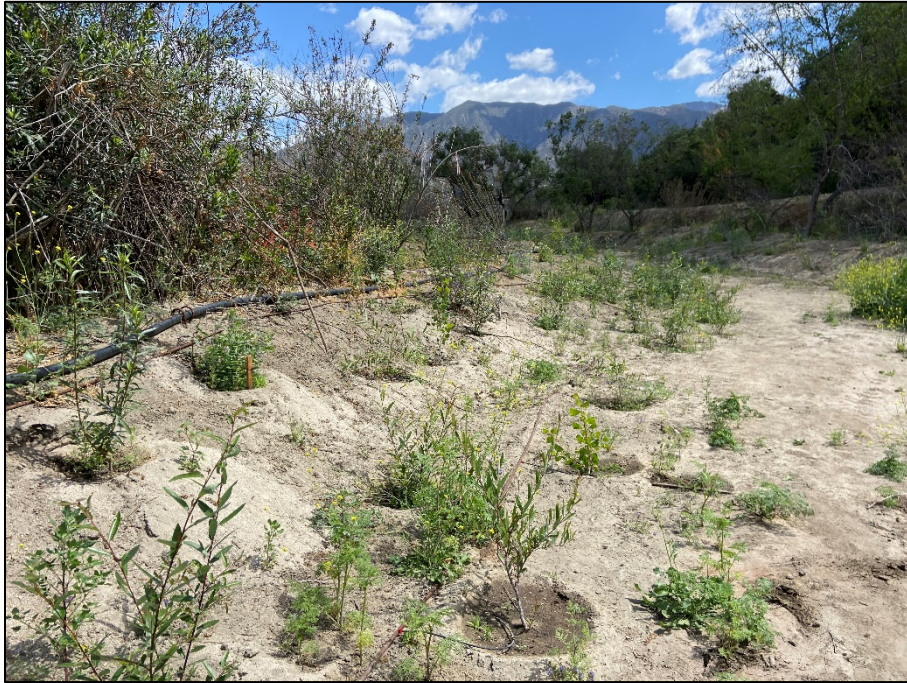
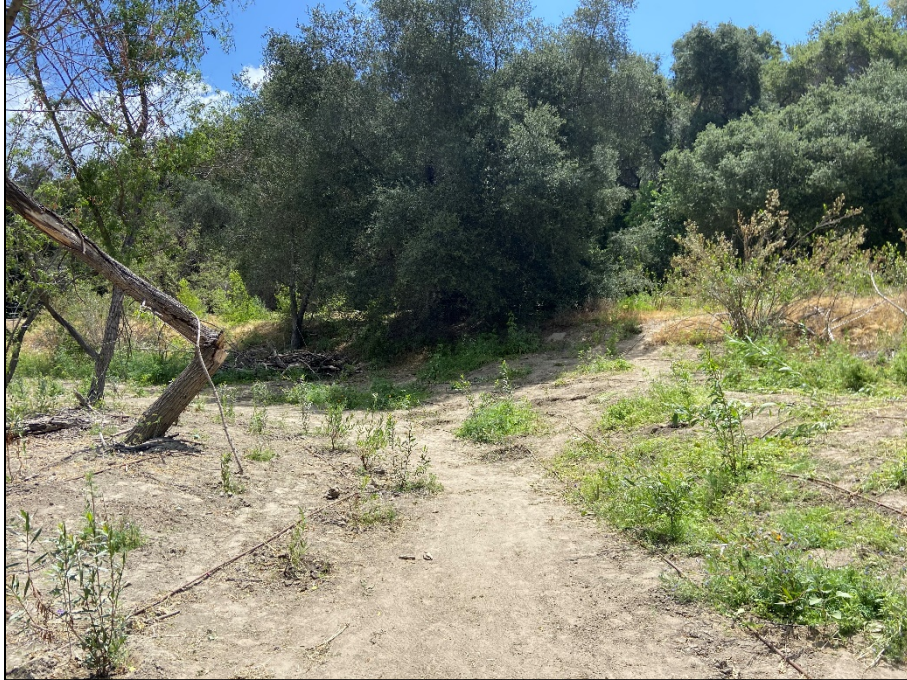
The overall health of the container plants in DG-2, DG-2 New Channels, and DG-2 WOUS was noted as being good. Approximately five percent of the container plants were noted as showing varied levels of stress and a negligible number were noted as being dead or missing. Stress may be occurring due to similar reasons described for DG-W-1. Formal mortality counts will be taken for DG-2, DG-2 New Channels, and DG-2 WOUS during the 2021 quantitative monitoring and will be included in the 2021 annual reporting. Some of the container plants were noted as lacking well defined basins and should have their basins properly constructed and/or repaired. The installation of plants in the DG-2, DG-2 New Channels, and DG-2 WOUS mitigation areas appears to have been completed successfully. The current issues identified during the monitoring visit are not expected to have an effect on the continued growth of the plants in the mitigation area. Photos 4 through 11 in Attachment B document the mitigation areas during the monitoring visit.

Nonnative weed cover in DG-2, DG-2 New Channels, and DG-2 WOUS mitigation areas was estimated at approximately 10 percent and weed abatement was actively occurring during the monitoring. Nonnative species observed included black mustard, poison hemlock, and perennial pepperweed (*Lepidium latifolium*). Many of the nonnative weeds observed in this mitigation area are starting to flower and will soon go to seed.

Photo 4: Overview Mitigation Area DG-2

Photo 5: Overview Mitigation Area DG-2

Photo 6: Overview Mitigation Area DG-2

Photo 7: Overview Mitigation Area DG-2 New Channels

Photo 8: DG-2 New Channels

Photo 9: Overview Mitigation Area DG-2 New Channels

Photo 10: Overview Mitigation Area DG-2 WOUS

Photo 11: Overview Mitigation Area DG-2 WOUS

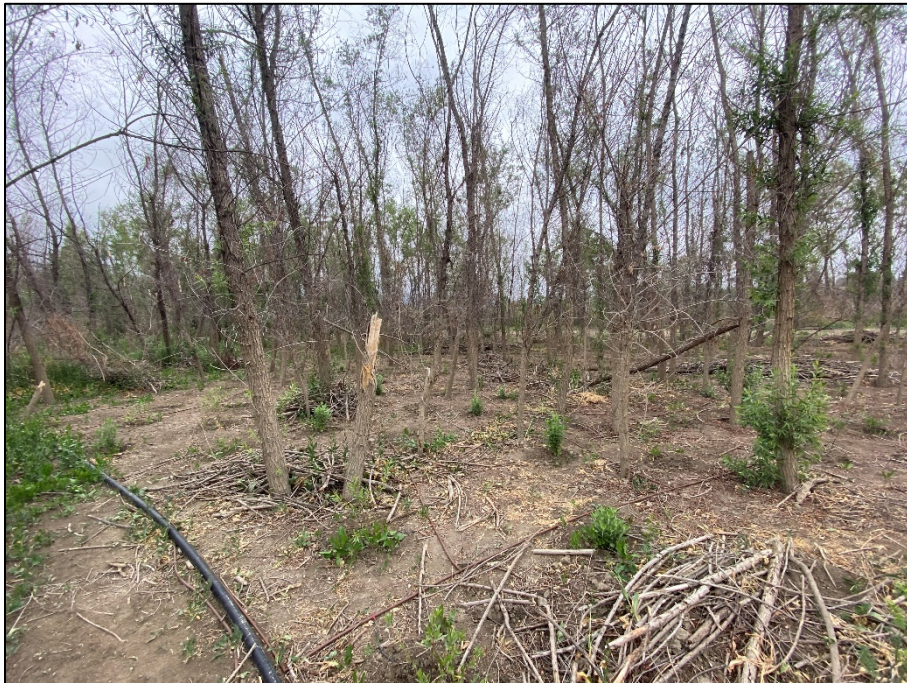
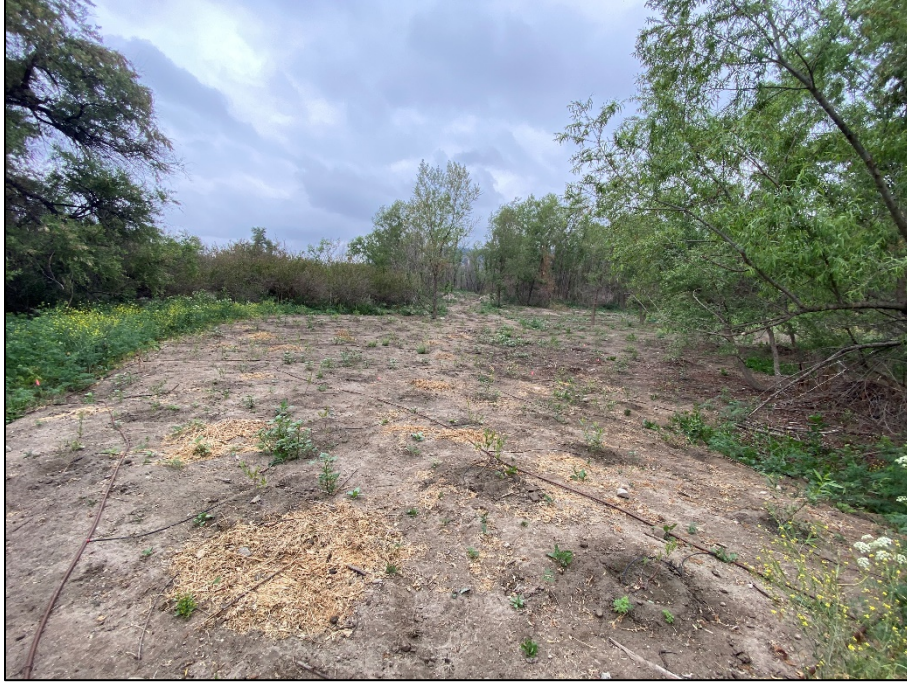
The overall health of the container plants in mitigation area DG-W-2 was noted as being good. Approximately five percent of the container plants were noted as showing varied levels of stress and a negligible number were noted as being dead or missing. Stress may be occurring due to similar reasons described for DG-W-1. Formal mortality counts will be taken for DG-W-2 during the 2021 quantitative monitoring and will be included in the 2021 annual reporting. Some of the container plants were noted as lacking well defined basins and should have their basins properly constructed and/or repaired. In addition, minor herbivory of young plants was observed within the DG-W-2 mitigation area and should continue to be monitored. The installation of plants in the DG-W-2 mitigation area appears to have been completed successfully and the issues noted during the monitoring are not expected to have an impact on the continued growth of the plants. Photos 12 through 13 in Attachment B document the mitigation area during the monitoring visit.

Nonnative weed cover in DG-W-2 was estimated at approximately 10 percent. Nonnative species observed in DG-W-2 included black mustard, poison hemlock, and perennial pepperweed. Nonnative weeds in this area were just beginning to germinate and were mostly vegetative (i.e. no flowers or seeds).

Photo 12: Overview Mitigation Area DG-W-2 (Mining Pit)

Photo 13: Overview Mitigation Area DG-W-2 (Mining Pit)

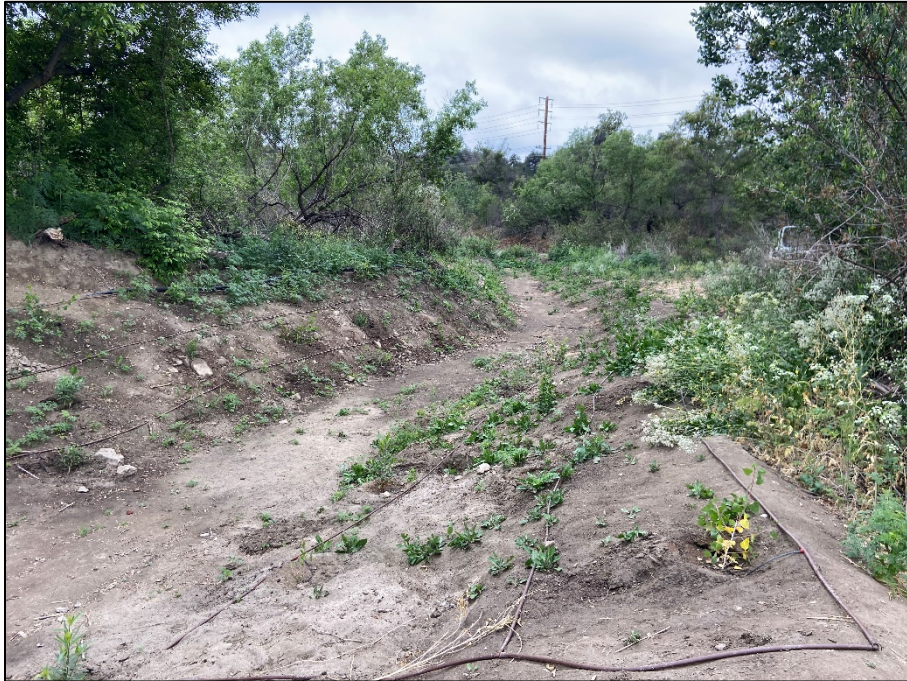
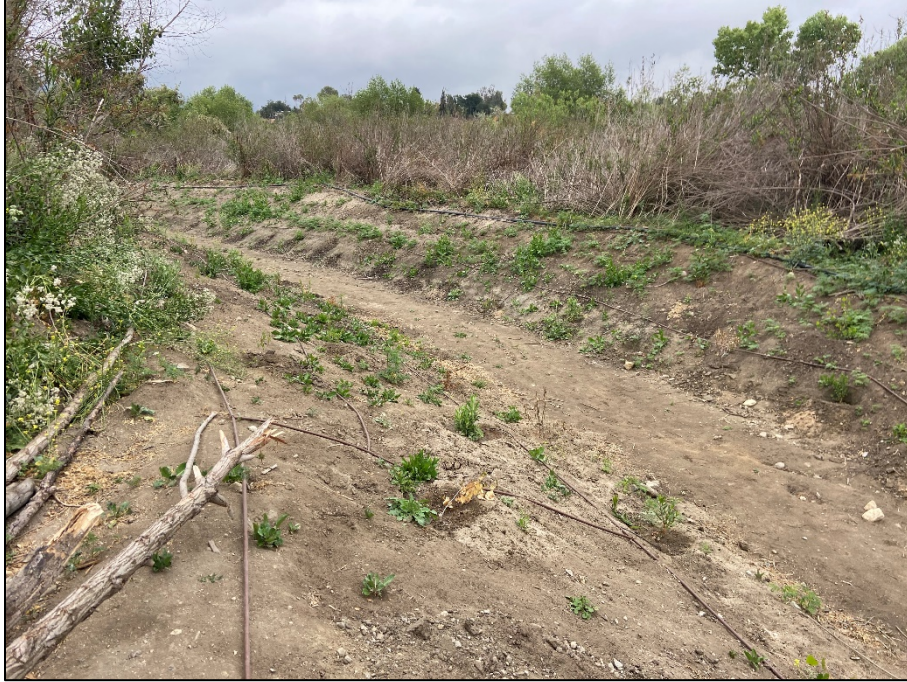
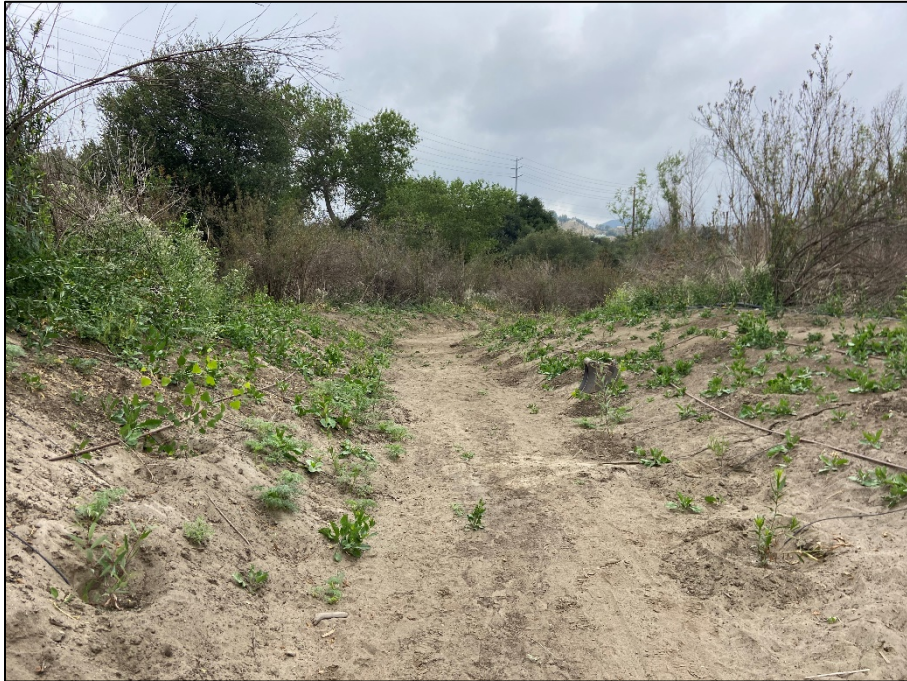
The overall health of the container plants in mitigation area DG-W-2 Outlet was noted as being good. Approximately 10 percent of the container plants were noted as showing varied levels of stress and a negligible number were noted as being dead or missing. Stress may be occurring due to similar reasons described for DG-W-1. Formal mortality counts will be taken for DG-W-2 Outlet during the 2021 quantitative monitoring and will be included in the 2021 annual reporting. Some of the container plants were noted as lacking well defined basins and should have their basins properly constructed and/or repaired. In addition, minor herbivory of young plants was observed within the DG-W-2 Outlet mitigation area and should continue to be monitored. The installation of plants in the DG-W-2 Outlet mitigation area appears to have been completed successfully and the issues noted during the monitoring are not expected to have an impact on the continued growth of the plants. Photos 14 through 16 in Attachment B document the mitigation area during the monitoring visit.

Nonnative weed cover in DG-W-2 Outlet was estimated at approximately 15 percent. Nonnative species observed in DG-W-2 included black mustard, poison hemlock, perennial pepperweed, and tree tobacco (*Nicotiana glauca*). Nonnative weeds in this area were just beginning to germinate and were mostly vegetative (i.e. no flowers or seeds).

Photo 14: Overview Mitigation Area DG-W-2 (Mining Pit Outlet)

Photo 15: Overview Mitigation Area DG-W-2 (Mining Pit Outlet)

Photo 16: Overview Mitigation Area DG-W-2 (Mining Pit Outlet)

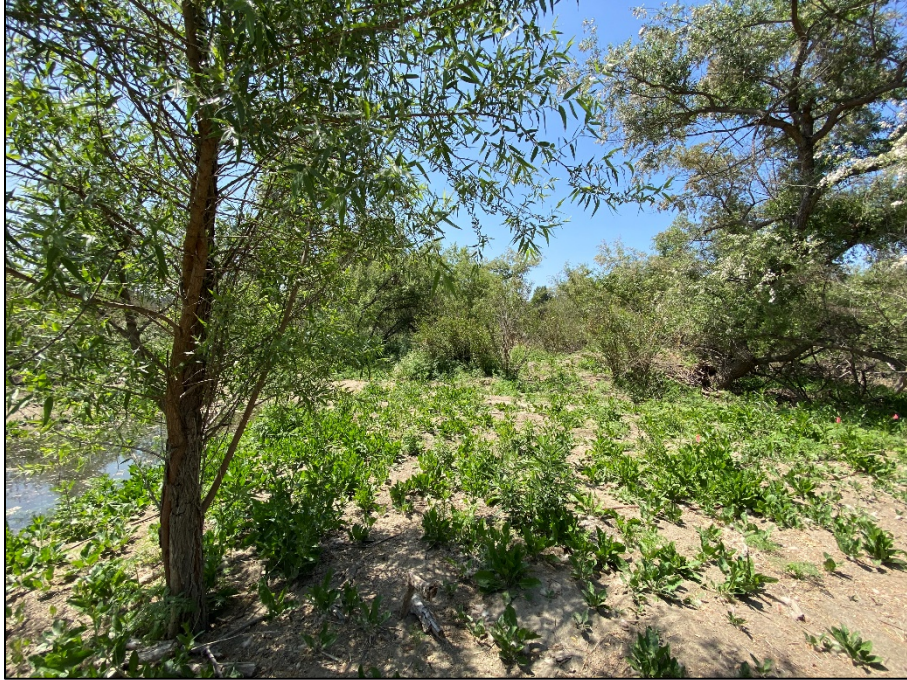
The overall health of the container plants in mitigation areas DG-4 Sheet Flow and DG-SF-1 was noted as being good. Approximately 10 percent of the container plants were noted as showing varied levels of stress and a negligible number were noted as being dead or missing. Stress may be occurring due to similar reasons described for DG-W-1. Formal mortality counts will be taken during the 2021 quantitative monitoring and will be included in the 2021 annual reporting. Some of the container plants were noted as lacking well defined basins and should have their basins properly constructed and/or repaired. In addition, minor herbivory of young plants was observed within the DG-4 Sheet Flow and DG-SF-1 areas and should continue to be monitored. The installation of plants in the DG-4 Sheet Flow and DG-SF-1 mitigation areas appears to have been completed successfully and the issues noted during the monitoring are not expected to have an impact on the continued growth of the plants. Photo 17 in Attachment B documents the mitigation area during the monitoring visit.

Nonnative weed cover in DG-4 Sheet Flow and DG-SF-1 was estimated at approximately 15 percent. Nonnative species observed in DG-4 Sheet Flow and DG-SF-1 included black mustard, poison hemlock, and perennial pepperweed. Nonnative weeds in this area were just beginning to germinate and were mostly vegetative (i.e. no flowers or seeds).

Photo 17: Overview Mitigation Area DG-4 Sheet Flow/DG-SF-1
