January 4, 2023  
2017-116.006

**Re: *Devil's Gate Reservoir Restoration Project – Phase 2 Restoration Qualitative Monitoring Conducted on November 28, 2022***

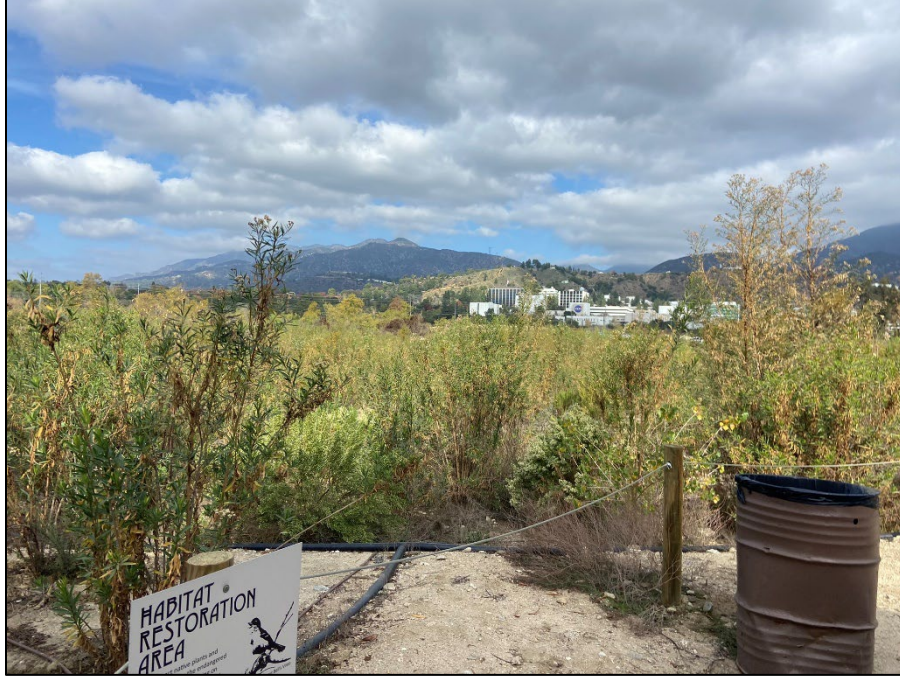
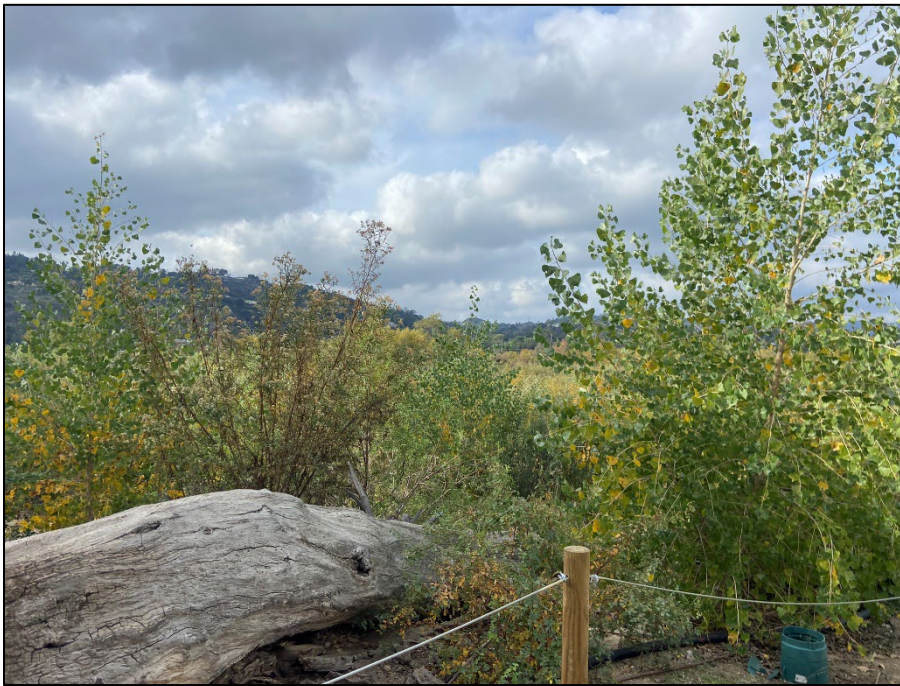
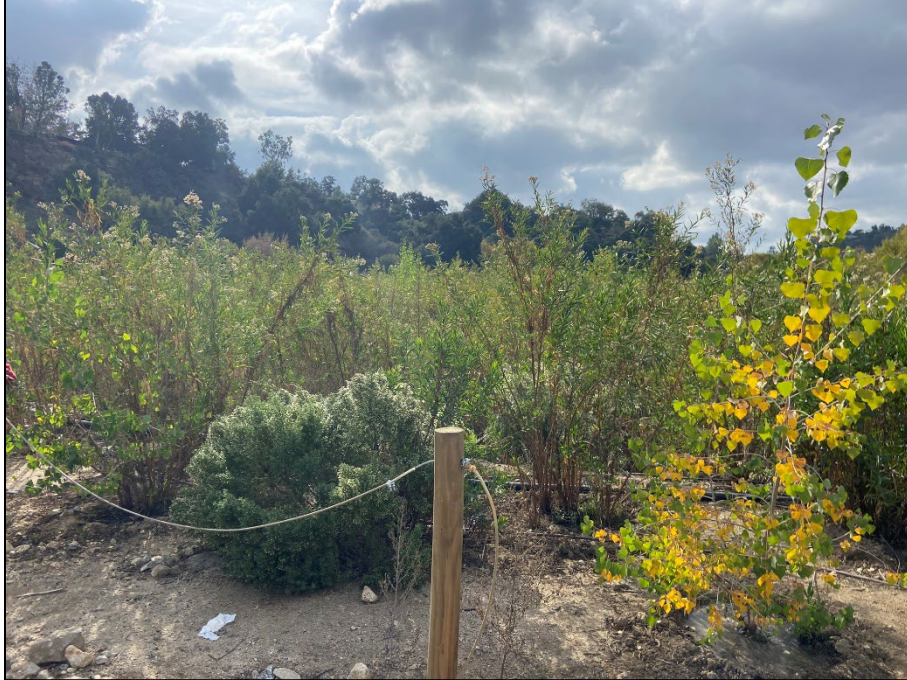
The overall health of the container plants in DG-W-1 was noted as being good. Approximately 5 to 10 percent of the container plants in DG-W-1 were noted as showing varied levels of stress and a negligible number were noted as being dead or missing. This is approximately five percent less than the percentage of plants that were showing stress during the last monitoring event. Stress may be occurring as a result of 1) herbivory by rabbits or other wildlife, 2) competition from nonnative and invasive weeds, 3) misplaced emitters, or 4) recreational traffic through the mitigation areas. In addition, some of the mulefat (*Baccharis salicifolia*) in this mitigation area were showing signs of minor dieback that appeared to be the result of *Baccharis* leaf blister and/or dodder (*Cuscuta* sp.). A handful of Fremont's cottonwoods (*Populus fremontii*) were also showing minor dieback which appeared to be the result of natural recruitment of mulefat within their basins. Evidence of dieback from *Phytophthora cactorum*, including wilting, stunted growth, leaf spotting, and/or browning along leaf margins and tips, was not observed on any of the container plants. The willows (*Salix* sp.) and Fremont's cottonwoods (*Populus fremontii*) in this mitigation area were starting to show minor seasonal dieback. Formal mortality counts were taken for DG-W-1 during the 2021 and 2022 quantitative monitoring events. Some of the container plants were noted as lacking well defined basins and should have their basins properly constructed and/or repaired. The irrigation line appeared to be functioning properly for the mitigation area during the monitoring visit. The installation of plants in the DG-W-1 mitigation area appears to have been completed successfully. The current issues identified during the monitoring visit are not expected to have an effect on the continued growth of the plants in the mitigation area. Photos 1 through 3 in Attachment B document the mitigation area during the monitoring visit.

two-color rabbit-tobacco (*Pseudognaphalium biolettii*) were observed sprouting in the DG-W-1 mitigation area. The dodder that was observed growing on some of the young container plants during the previous monitoring visit appeared to have been removed. Native cover was estimated to be approximately 75 percent in the DG-W-1 mitigation area.

Nonnative weed cover in DG-W-1 was estimated at approximately less than one percent, which is approximately the same as the level of weed cover that was observed during the previous monitoring visit. The only nonnative species observed in DG-W-1 was white horehound (*Marrubium vulgare*). All of the nonnative weeds observed in this mitigation area were still vegetative and just beginning to germinate.

Photo 1: Overview Mitigation Area DG-W-1 (Johnson Field)

Photo 2: Overview Mitigation Area Overview Mitigation Area DG-W-1 (Johnson Field)

Photo 3: Overview Mitigation Area Overview Mitigation Area DG-W-1 (Johnson Field)

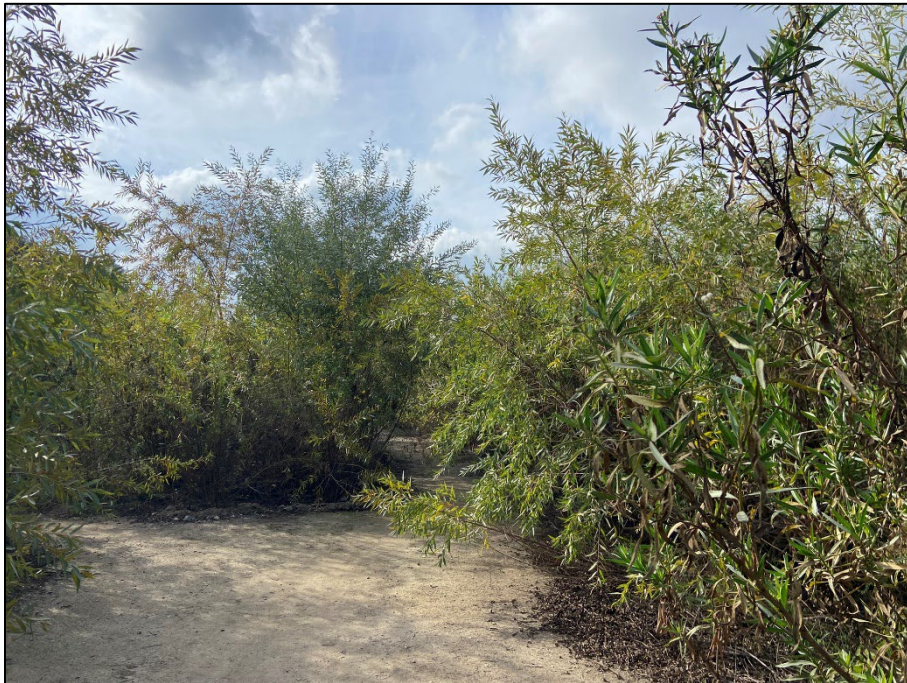
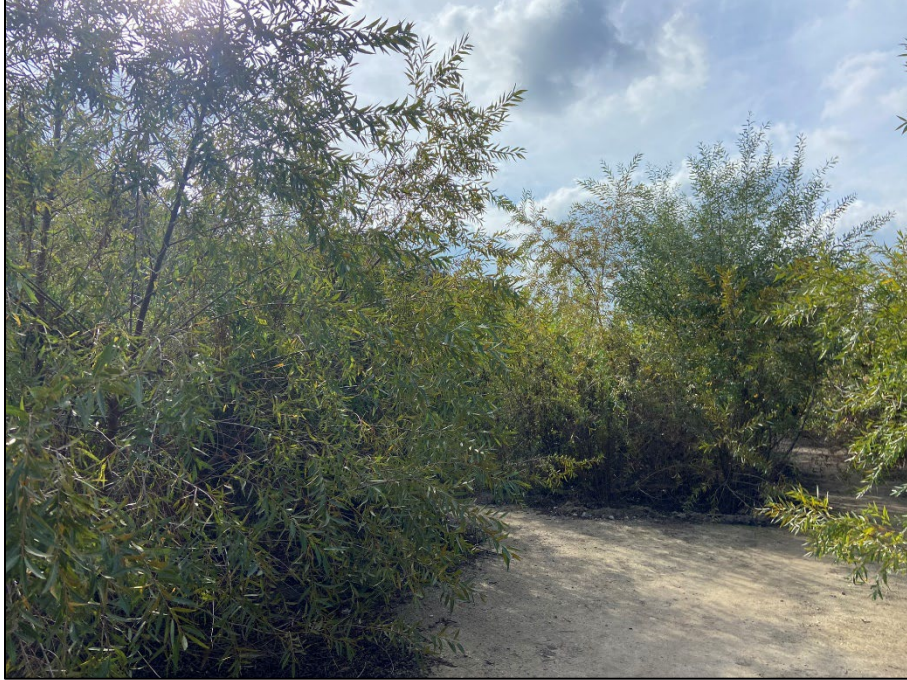
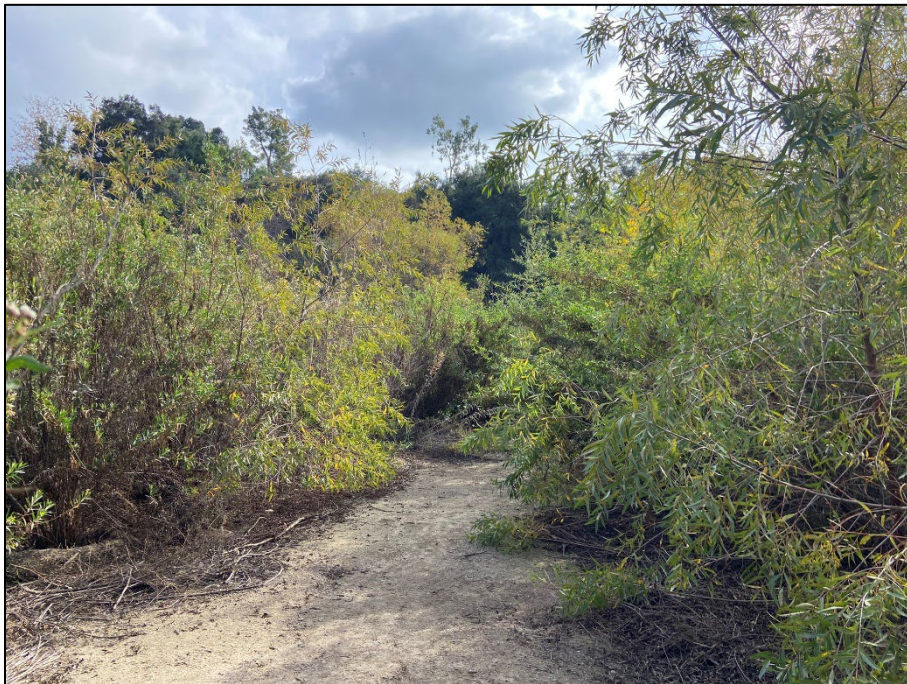
The overall health of the container plants in DG-2, DG-2 New Channels, and DG-2 WOUS was noted as being good. Approximately less than five percent of the container plants were noted as showing varied levels of stress and a negligible number were noted as being dead or missing. This is approximately the same percentage of plants that were showing stress during the last monitoring event. Stress may be occurring due to similar reasons described for DG-W-1. Evidence of dieback from *Phytophthora cactorum*, including wilting, stunted growth, leaf spotting, and/or browning along leaf margins and tips, was not observed on any of the container plants. Similar to DG-W-1, the willows and Fremont's cottonwoods in this mitigation area were starting to show minor seasonal dieback. Formal mortality counts were taken for DG-2, DG-2 New Channels, and DG-2 WOUS during the 2021 and 2022 quantitative monitoring events. Some of the container plants were noted as lacking well defined basins and should have their basins properly constructed and/or repaired. The irrigation line appeared to be functioning properly during the monitoring visit. During the monitoring visit, the grade control structure that was installed at the northern end of DG-2 New Channels where the channels connect to DG-W-1 was inspected for erosion. Minor erosion was observed, mostly towards the western end of the structure; however, no major erosion issues were observed, and the structure appears to be functioning properly. The installation of plants in the DG-2, DG-2 New Channels, and DG-2 WOUS mitigation areas appears to have been completed successfully. The current issues identified during the monitoring visit are not expected to have an effect on the continued growth of the plants in the mitigation area. Photos 4 through 6 in Attachment B document the mitigation areas during the monitoring visit.

Native plant growth was noted throughout the DG-2, DG-2 New Channels, and DG-2 WOUS mitigation areas, likely from both natural recruitment and from seeding. Native plants such as California sagebrush (*Artemisia californica*), mugwort, coyote brush (*Baccharis pilularis*), mulefat, curvepod yellowcress (*Rorippa curvisiliqua*), and stinging nettle (*Urtica dioica*) were observed sprouting in the mitigation areas. The dodder that was observed growing on some of the young container plants during the previous monitoring visit appeared to have been removed. Native cover was estimated to be approximately 75 percent in the DG-2, DG-2 New Channels, and DG-2 WOUS mitigation areas.

Nonnative weed cover in the DG-2, DG-2 New Channels, and DG-2 WOUS mitigation areas was estimated at approximately less than one percent, which is approximately the same percentage that was observed

during the last monitoring visit. The only nonnative species observed was perennial pepperweed (*Lepidium latifolium*). All of the nonnative weeds observed in this mitigation area were vegetative and just starting to germinate.

Photo 4: Overview Mitigation Area DG-2 & DG-2 New Channels

Photo 5: Overview Mitigation Area DG-2 & DG-2 New Channels

Photo 6: Overview Mitigation Area DG-2 & DG-2 WOUS

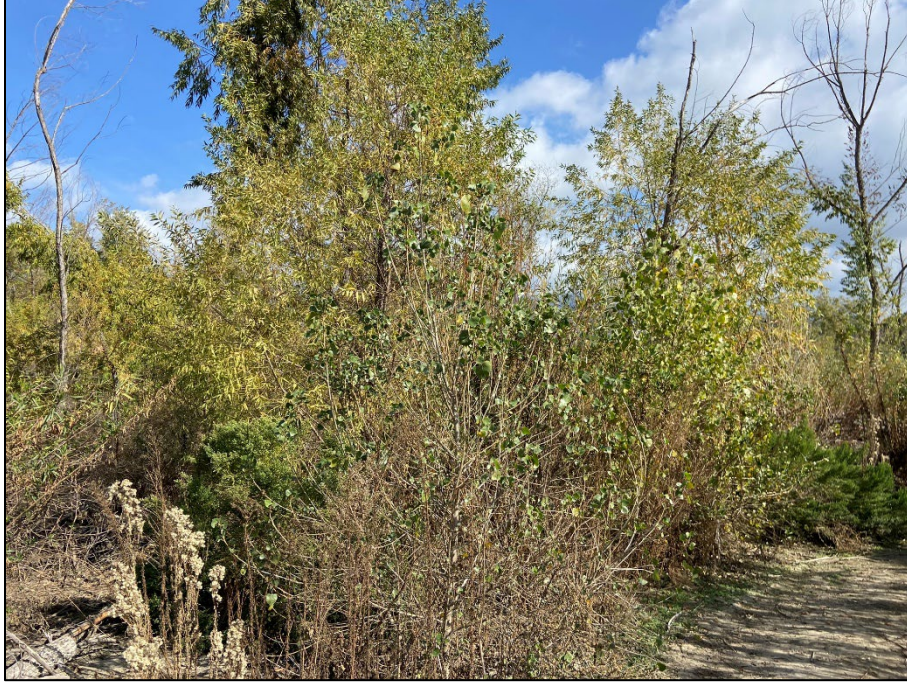
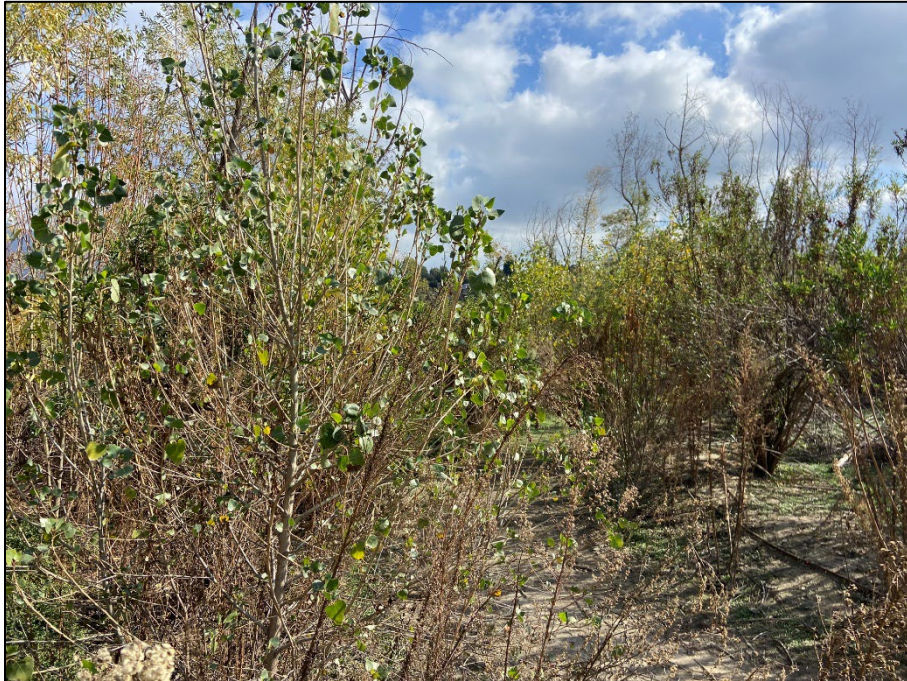
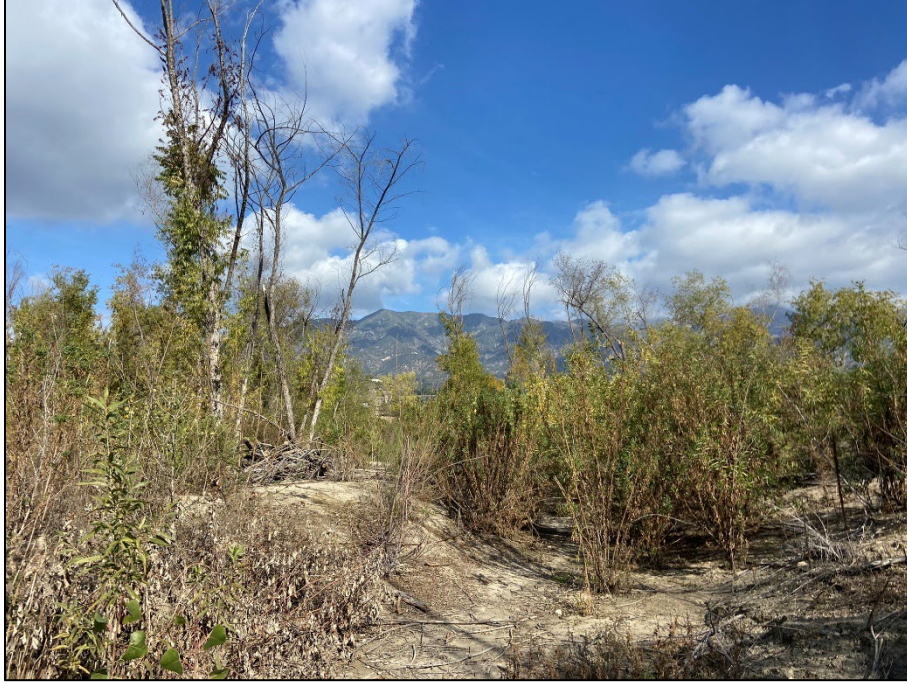
The overall health of the container plants in mitigation area DG-W-2 was noted as being good. Approximately 10 to 15 percent of the container plants were noted as showing varied levels of stress and a negligible number were noted as being dead or missing. This is approximately 10 percent lower than the percentage of plants that were showing stress during the last monitoring event. Stress may be occurring due to similar reasons described for DG-W-1. Evidence of dieback from *Phytophthora cactorum*, including wilting, stunted growth, leaf spotting, and/or browning along leaf margins and tips, was not observed on any of the container plants. Similar to DG-W-1, the willows and Fremont's cottonwoods in this mitigation area were starting to show minor seasonal dieback. Formal mortality counts were taken for DG-W-2 during the 2021 and 2022 quantitative monitoring events. Some of the container plants were noted as lacking well defined basins and should have their basins properly constructed and/or repaired. The irrigation line appeared to be functioning properly for most areas of the mitigation area during the monitoring visit; however, some basins appeared to be dry and should be inspected for functionality. The installation of plants in the DG-W-2 mitigation area appears to have been completed successfully and the issues noted during the monitoring are not expected to have an impact on the continued growth of the plants. Photos 7 through 9 in Attachment B document the mitigation area during the monitoring visit.

During the monitoring visit, it was noted that many of the remaining mature black willows (*Salix gooddingii*) in this mitigation area were continuing to show dieback and were not showing signs of recovery from the polyphagous shot-hole borer (PSHB) infestation that was confirmed by the Los Angeles County Department of Agricultural Commissioner/Weights & Measures in December of 2021. The majority of the dead and hazardous black willows in this mitigation area were removed in October of 2022. Black willows that were determined to have the potential to recover were left in place and will be monitored during the qualitative monitoring visits.

Native plant growth was noted throughout the DG-W-2 mitigation area, and what was present is likely from both natural recruitment and from seeding. Native plants such as annual bursage, mulefat, Canada horseweed, telegraph weed, and rough cocklebur (*Xanthium strumarium*) were observed sprouting in the DG-W-2 mitigation area. It was noted that the dodder observed growing on some of the young container plants during previous monitoring visits had been removed. Native cover was estimated to be approximately 75 percent in the DG-W-2 mitigation area.

Nonnative weed cover in DG-W-2 was estimated at approximately two percent in the mitigation area, which is approximately three percent less than the level of nonnative cover that was observed during the last monitoring event. Nonnative species observed in DG-W-2 included poison hemlock (*Conium maculatum*), perennial pepperweed, and tree tobacco (*Nicotiana glauca*). Most of the nonnative weeds observed in this mitigation area were vegetative and just starting to germinate.

Photo 7: Overview Mitigation Area DG-W-2 (Mining Pit)

Photo 8: Overview Mitigation Area DG-W-2 (Mining Pit)

Photo 9: Overview Mitigation Area DG-W-2 (Mining Pit)

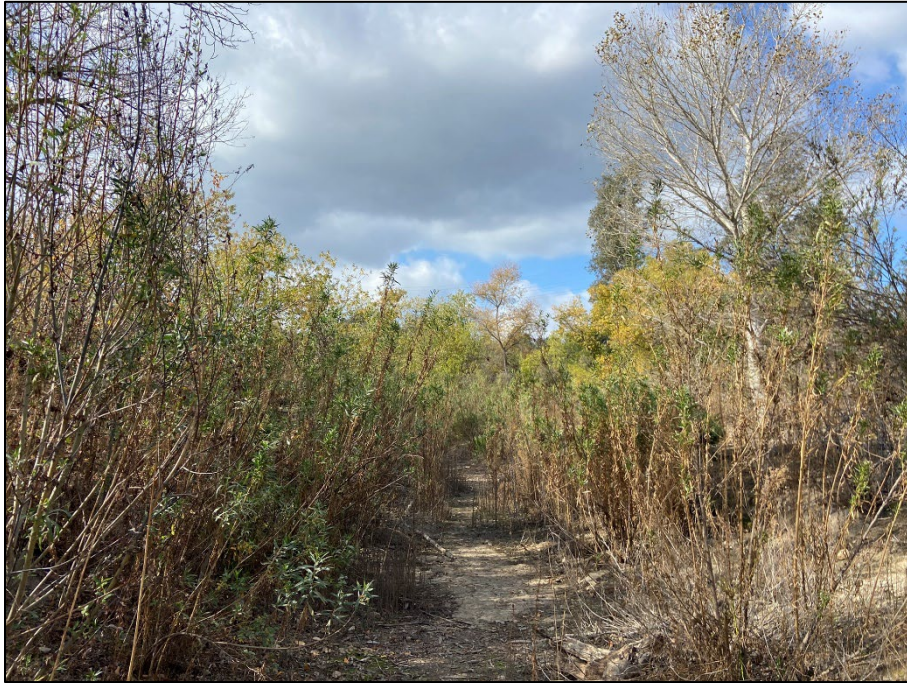
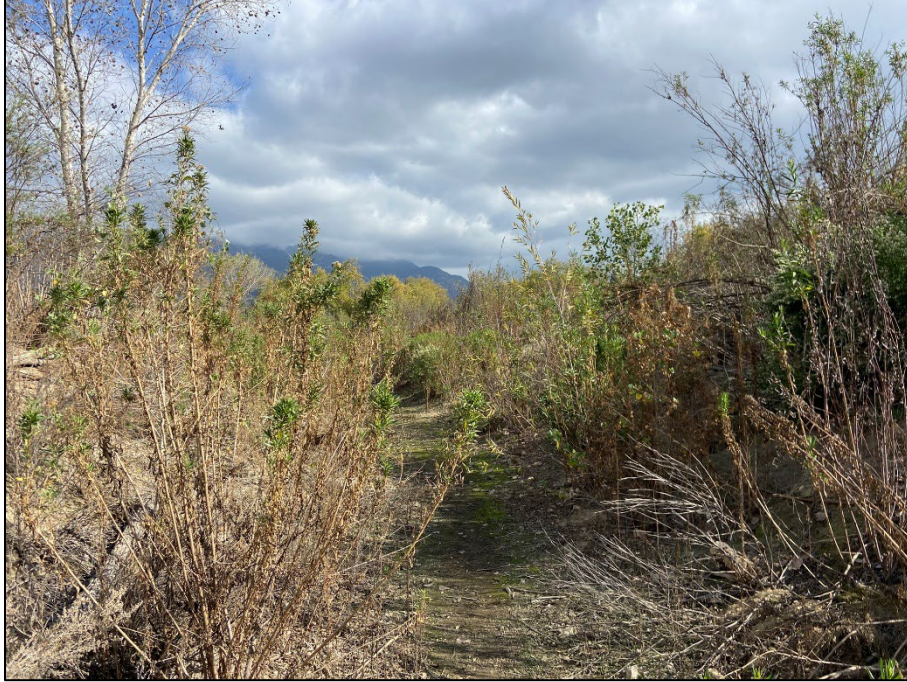
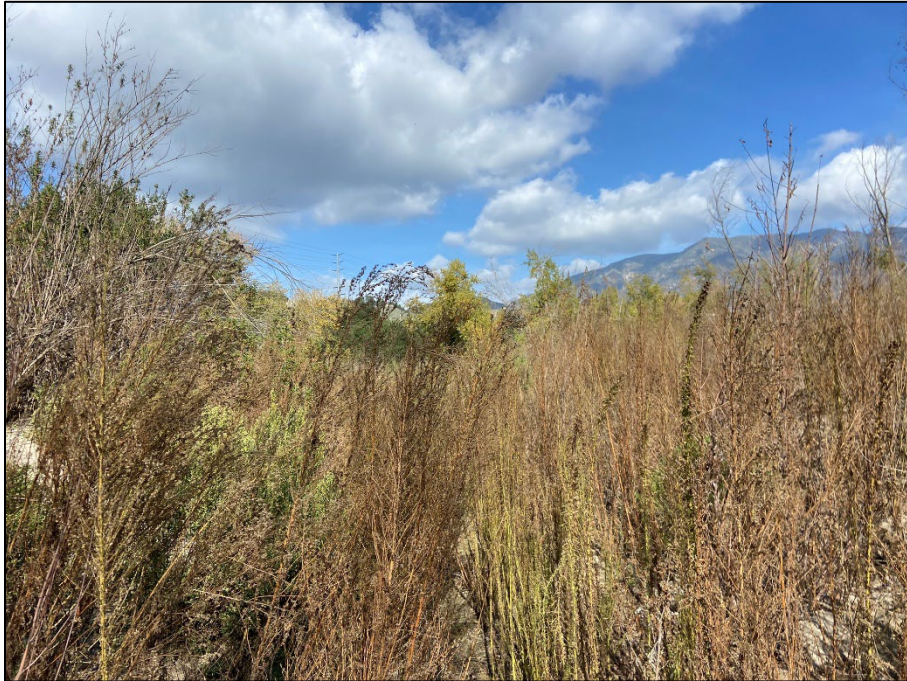
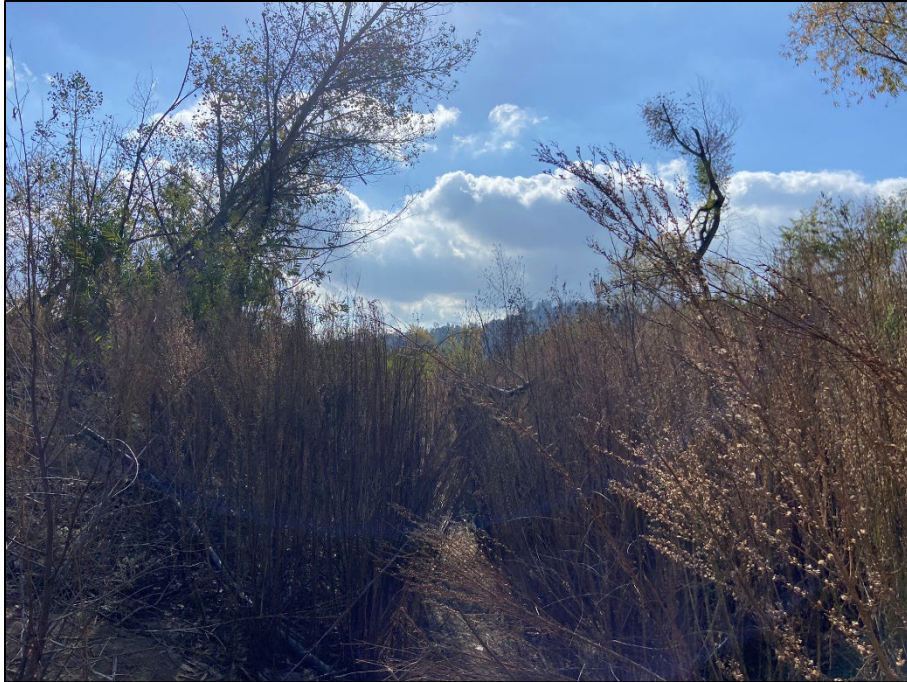
The overall health of the container plants in mitigation area DG-W-2 was noted as being good. Approximately 10 to 15 percent of the container plants were noted as showing varied levels of stress and a negligible number were noted as being dead or missing. This is approximately 15 percent lower than the percentage of plants that were showing stress during the last monitoring event. Stress may be occurring due to similar reasons described for DG-W-1. Evidence of dieback from *Phytophthora cactorum*, including wilting, stunted growth, leaf spotting, and/or browning along leaf margins and tips, was not observed on any of the container plants. Similar to DG-W-1, the willows and Fremont's cottonwoods in this mitigation area were starting to show minor seasonal dieback. Formal mortality counts were taken for DG-W-2 Outlet during the 2021 and 2022 quantitative monitoring events. Some of the container plants were noted as lacking well defined basins and should have their basins properly constructed and/or repaired. The irrigation line appeared to be functioning properly for most areas of the mitigation area during the monitoring visit; however, some basins appeared to be dry and should be inspected for functionality. The installation of plants in the DG-W-2 Outlet mitigation area appears to have been completed successfully and the issues noted during the monitoring are not expected to have an impact on the continued growth of the plants. Photos 10 through 13 in Attachment B document the mitigation area during the monitoring visit.

Native plant growth was noted throughout the DG-W-2 Outlet mitigation area, and what was present is likely from both natural recruitment and from seeding. Native plants such as mugwort, mulefat, tall flatsedge, and Canada horseweed were observed sprouting in the DG-W-2 Outlet mitigation area. Dodder that was previously noted on container plants appears to have been removed during recent maintenance activities. Native cover was estimated to be approximately 65 percent in the DG-W-2 Outlet mitigation area.

Nonnative weed cover in DG-W-2 Outlet was estimated to be approximately two percent, which is approximately one percent more than the percentage of weed cover that was observed during the previous monitoring visit. Nonnative species observed in DG-W-2 included poison hemlock, perennial pepperweed, and tree tobacco. All nonnative weeds observed in this mitigation area were vegetative and just starting to germinate.

Photo 10: Overview Mitigation Area DG-W-2 (Mining Pit Outlet)

Photo 11: Overview Mitigation Area DG-W-2 (Mining Pit Outlet)

Photo 12: Overview Mitigation Area DG-W-2 (Mining Pit Outlet)

Photo 13: Overview Mitigation Area DG-W-2 (Mining Pit Outlet)

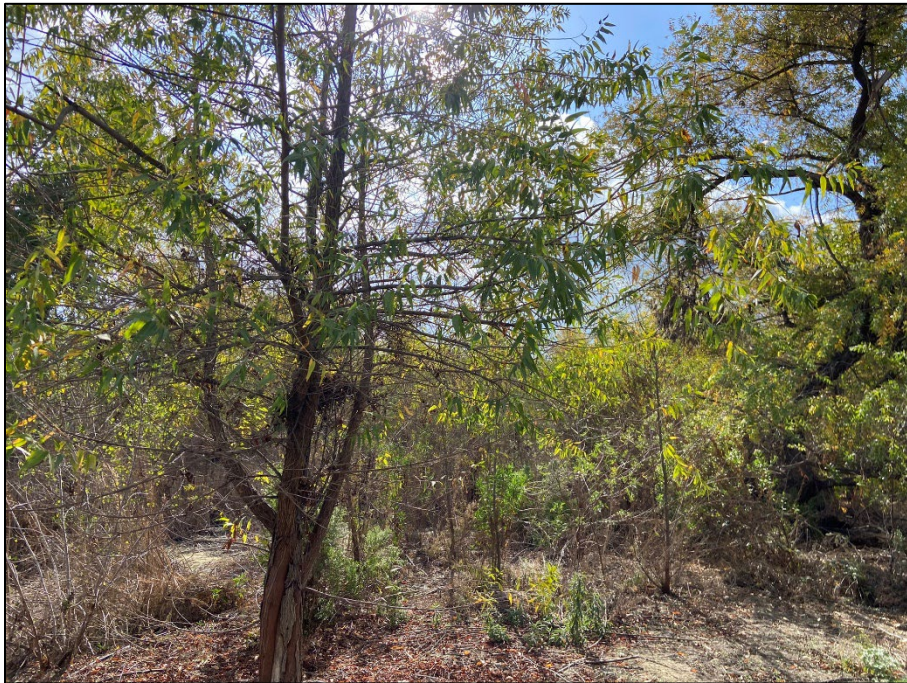
The overall health of the container plants in mitigation areas DG-4 Sheet Flow (northern) and DG-SF-1 was noted as being good. Approximately five percent of container plants were showing varied levels of stress which is approximately the same percentage of container plants that were showing stress during the previous monitoring event. Stress may be occurring due to similar reasons described for DG-W-1. Evidence of dieback from *Phytophthora cactorum*, including wilting, stunted growth, leaf spotting, and/or browning along leaf margins and tips, was not observed on any of the container plants. Similar to DG-W-1, the willows and Fremont's cottonwoods in this mitigation area were starting to show minor seasonal dieback. Formal mortality counts were taken during the 2021 and 2022 quantitative monitoring events. Some of the container plants were noted as lacking well defined basins and should have their basins properly constructed and/or repaired. In addition, minor herbivory of young plants was observed within

the DG-4 Sheet Flow and DG-SF-1 areas and should continue to be monitored. The irrigation line appeared to be functioning properly during the monitoring visit. The installation of plants in the DG-4 Sheet Flow and DG-SF-1 mitigation areas appears to have been completed successfully and the issues noted during the monitoring are not expected to have an impact on the continued growth of the plants. Photo 14 in Attachment B document the mitigation area during the monitoring visit.

Minimal native plant growth was noted throughout the DG-4 Sheet Flow and DG-SF-1 mitigation area, and what was present is likely from both natural recruitment and from seeding. Native plants such as mugwort and Canada horseweed were observed sprouting in the DG-4 Sheet Flow and DG-SF-1 mitigation areas. Native cover was estimated to be approximately 55 percent in the DG-4 Sheet Flow/DG-SF-1 mitigation area.

Nonnative weed cover in DG-4 Sheet Flow and DG-SF-1 was estimated at approximately less than one percent which is approximately four percent less than the level of weed cover that was observed during the previous monitoring visit. Nonnative species observed in DG-4 Sheet Flow and DG-SF-1 included poison hemlock and perennial pepperweed. All nonnative weeds observed in this mitigation area were vegetative and just starting to germinate.

Photo 14: Overview Mitigation Area DG-4 Sheet Flow/Sheet Flow-1
